# Belfast Hills Heritage Survey

SARAH GORMLEY

2013

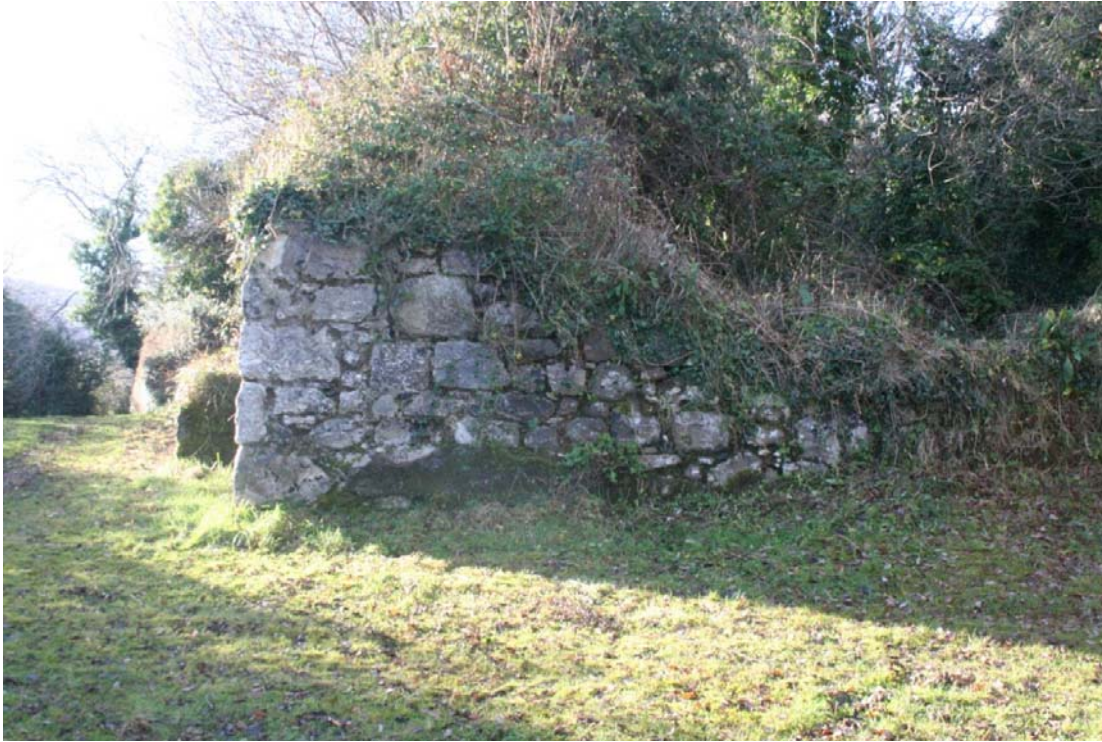
is built of basalt blocks, roughly 0.2m-0.4m high and although varying in length they are up to 0.8m long (Figure 1.6). The corners of the building are dressed with limestone quoins (Figure 1.6). There are some patches of render visible in places. The walls are in a fallen down condition and stand variously between 0.5m to 2m in height. The structure appears as three units, with a small extension to the rear. Given the Census return descriptions of a 5 and 6 room house, it seems likely that (in its later stages at least) the house was two storeys. Two windows are now evident at ground floor level. One in the front, measuring 1.2m across and one at the rear measuring 0.7m across. The room at the south-westernmost end was entranced from the outside by a door way in the south-eastern wall, 1.2m in width. This doorway has brick in the jamb and it may be that this opening was a later addition. There are no windows apparent in this room. It seems likely that this was, if not originally, then later used for animals, or as a store. The other two rooms are presumably interconnecting, although there is no evidence of this now and any internal door is masked by fallen masonry. A doorway opening, 1.1m wide, in the south-eastern wall provides access from the outside to the central room. The south-western wall in this room appeared to be thicker than the rest (which were 0.6m thick) at 0.9m thick and it may be that this was the location of the hearth and chimney. There is access from the north-easternmost room, through a doorway 0.85m wide, into the rear extension. The rear extension measures 5.9m by 2.6m and has an opening to the north-east and outside, measuring 1.25m wide.

Figure 1.6 – North-eastern wall of the farmhouse, looking south-west.

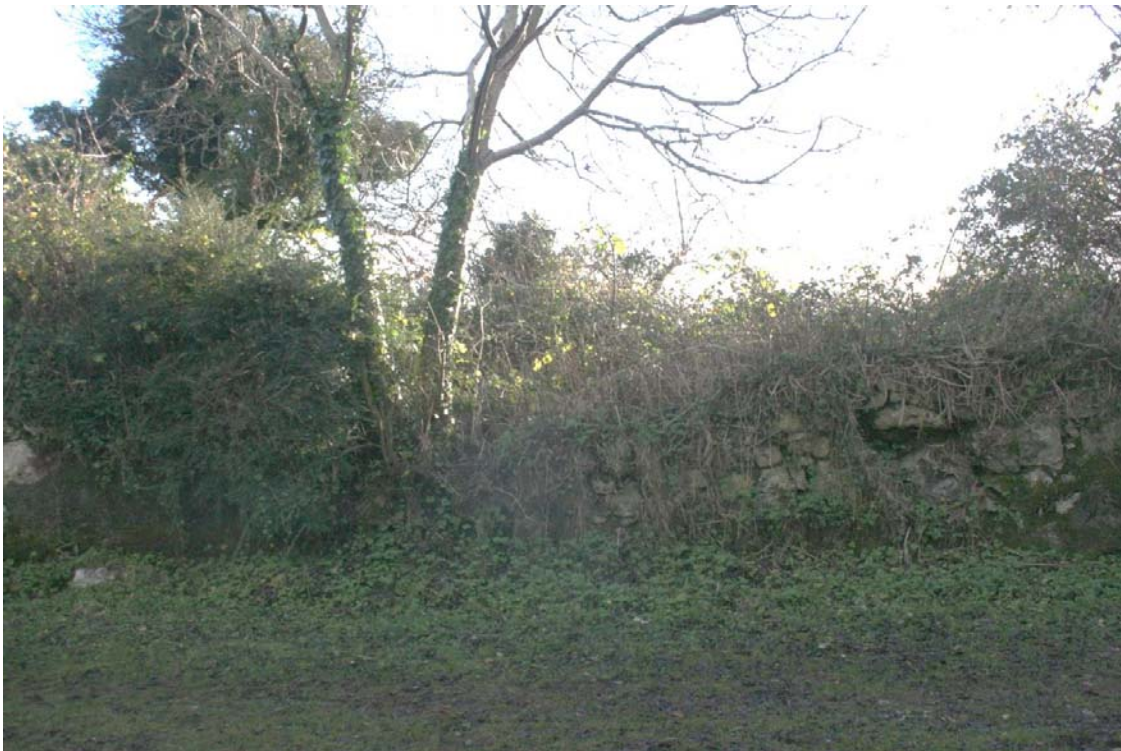
Figure 1.7 – North-western wall of building 'C', looking south-east.

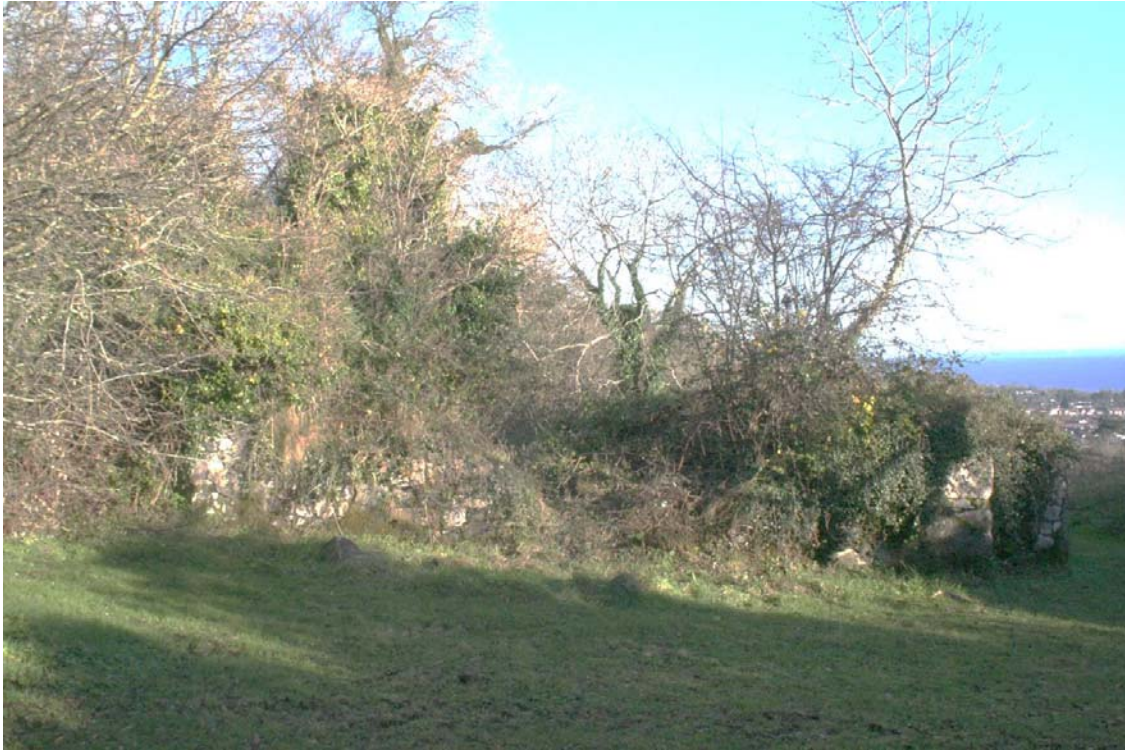
Figure 1.8 – Building 'B', south-western wall, looking north-east.

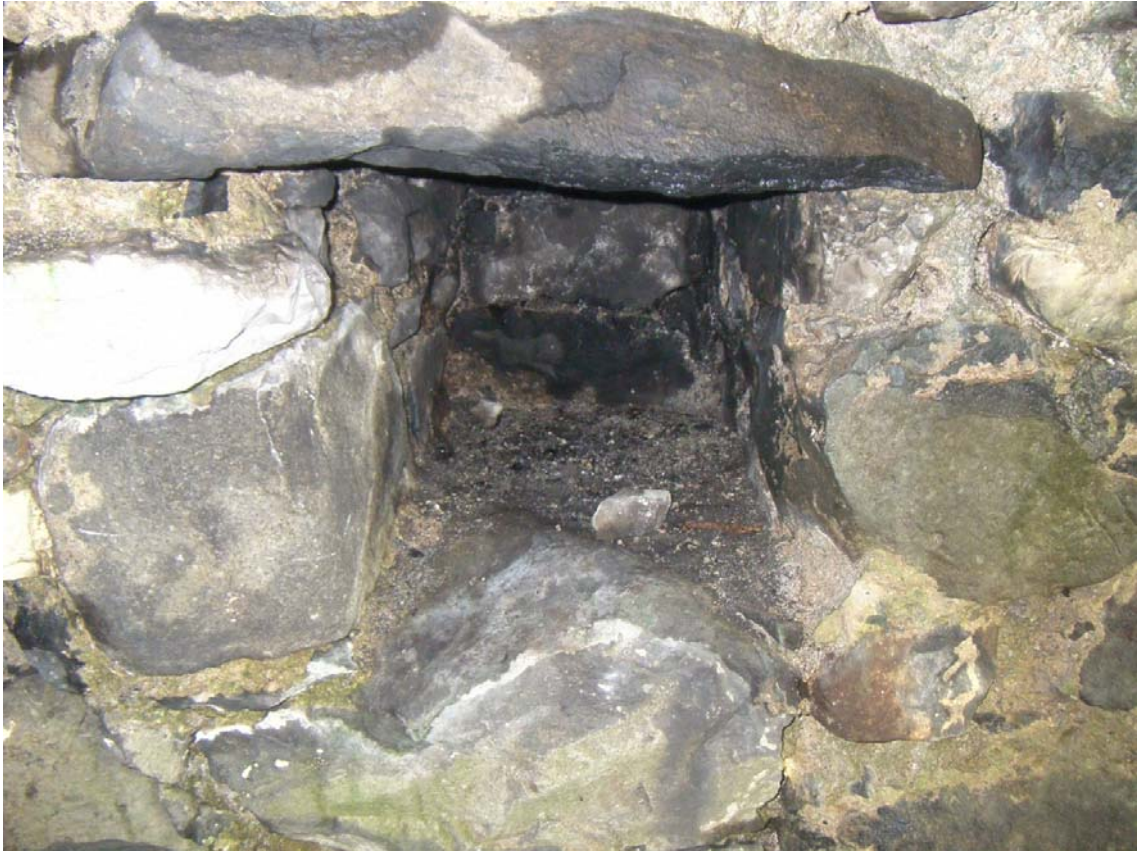
Figure 2.6 – Cavity within southern wall of the arched recess.

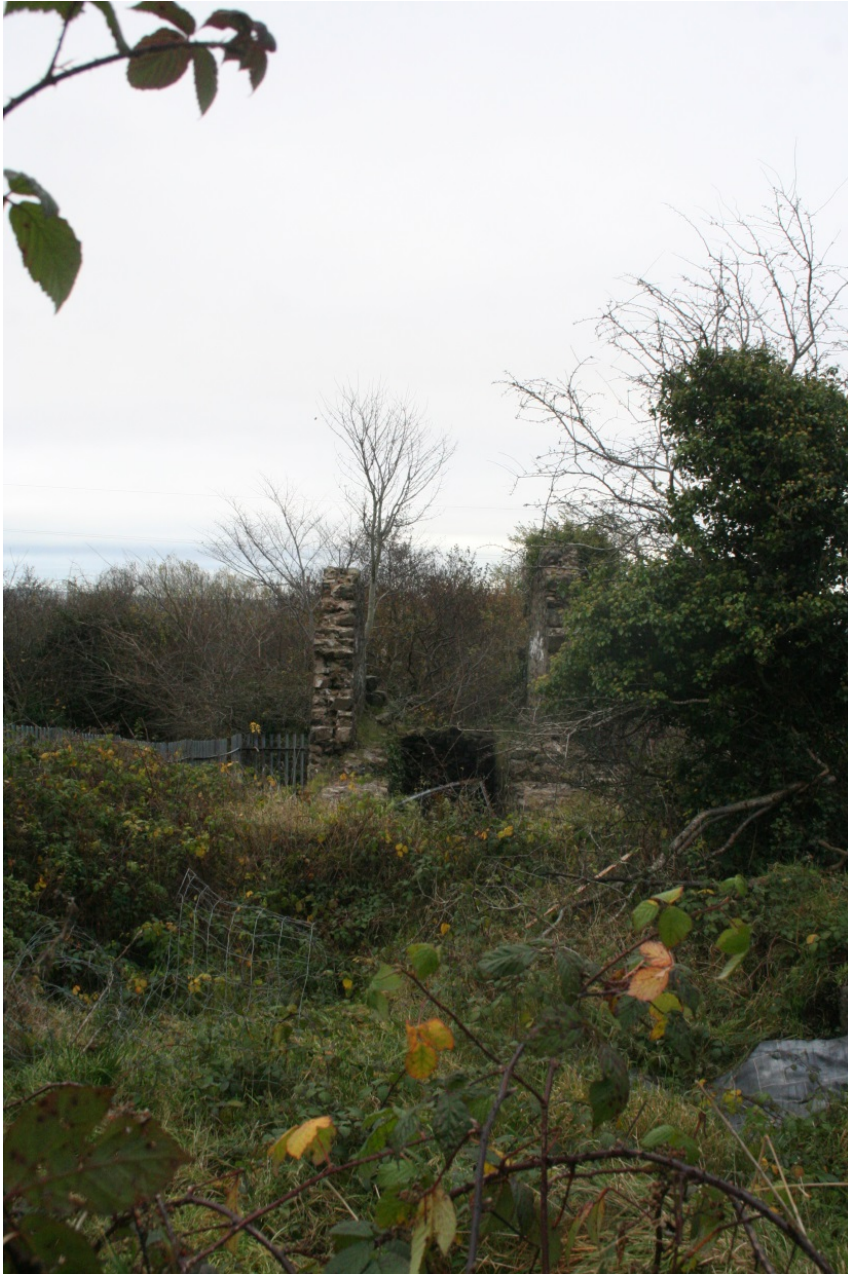
Figure 6.2 – The overgrown remains of the wheel pit, looking east.

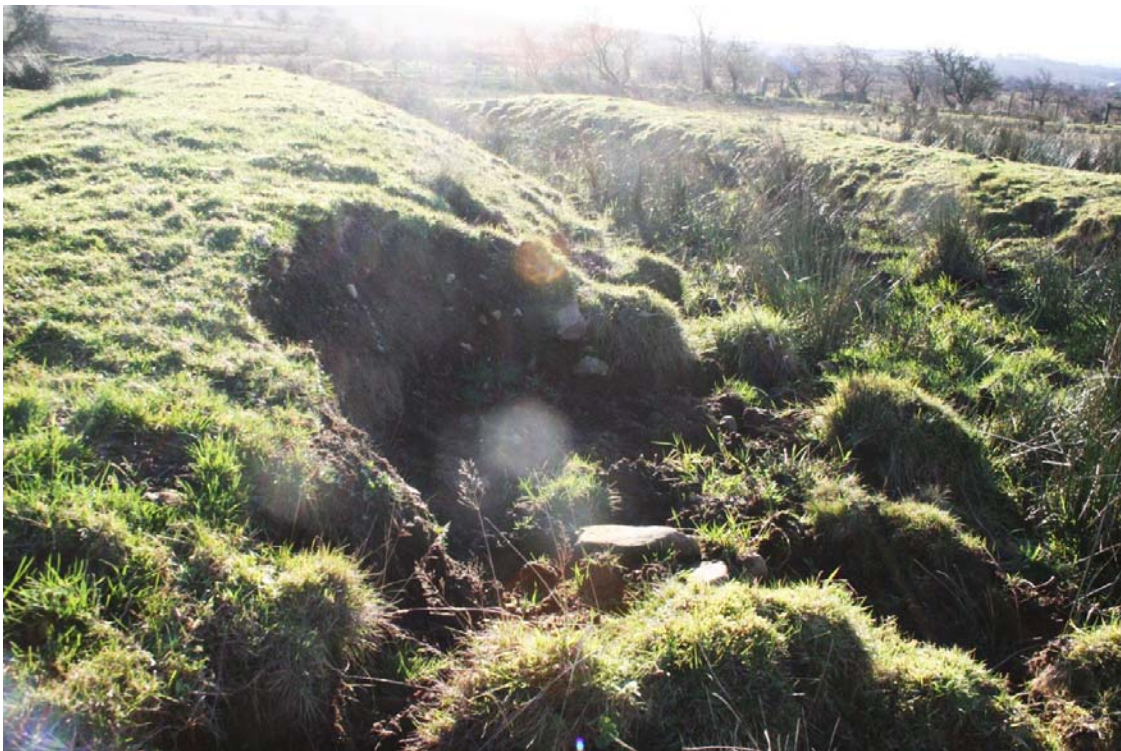
Figure 11.11 – Erosion to the bank at the south-west, looking south.

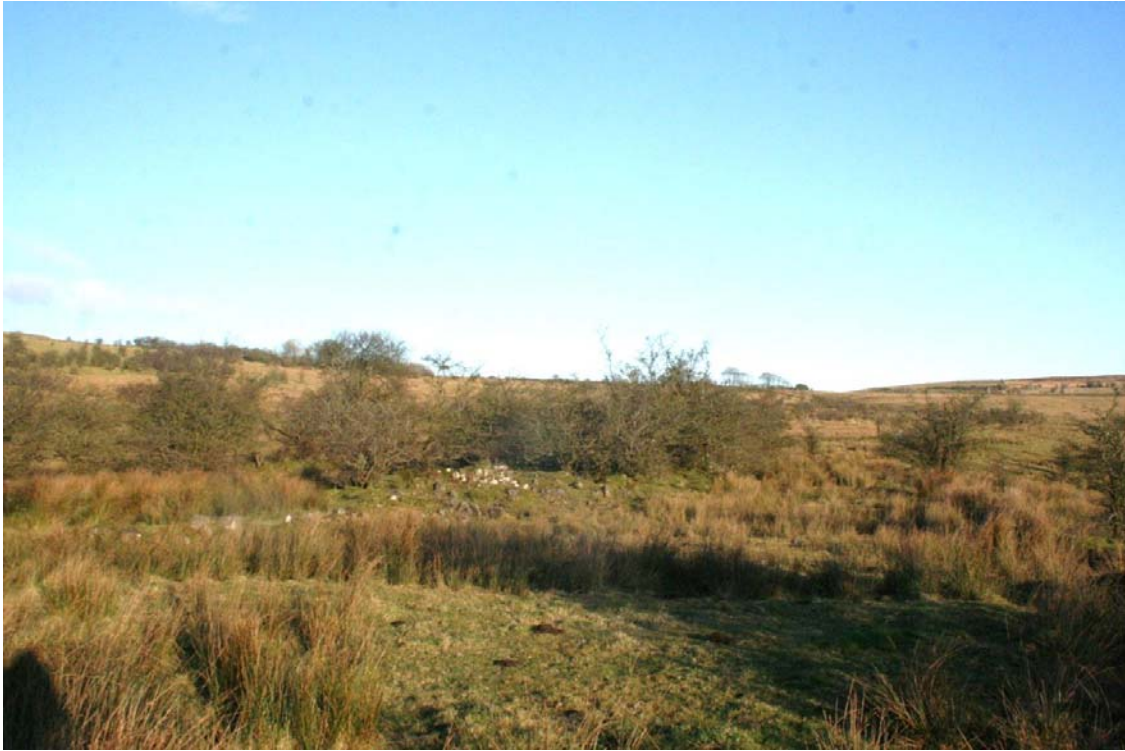
Figure12. 4 – The ruin is almost unrecognisable as a building, looking north-east.

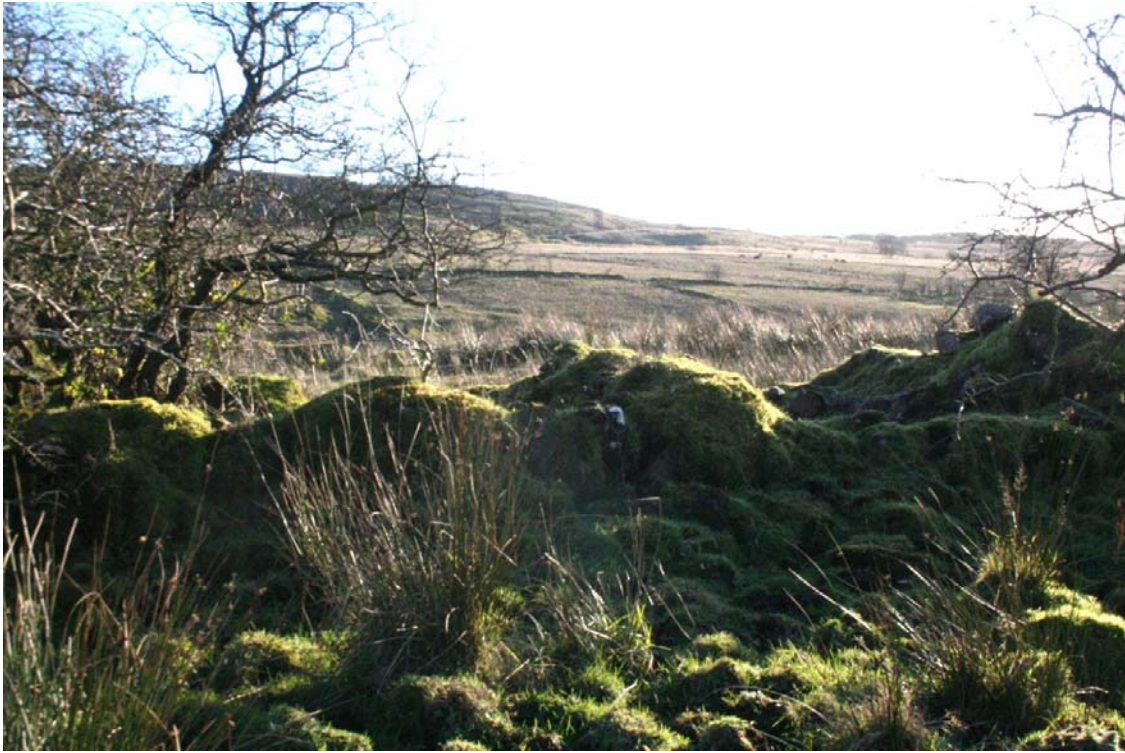
Figure 12.6 – Grass and moss covered remains of the row of buildings, looking south-south-west.
