**Survey Report: No. 3**  
**Photographic Survey of Corn**  
**Mill at Ligoniel, Belfast,**  
**County Antrim.**

**Site name:** Ligoniel dams

**Type of monument:** Corn Mill

Photographic survey undertaken 1.7.2014 by Lizzy Pinkerton, Geoff Wright, Karen Foreman, Michael Catney, Geraldine Caldwell, Robert Sayers and Kate Todd.

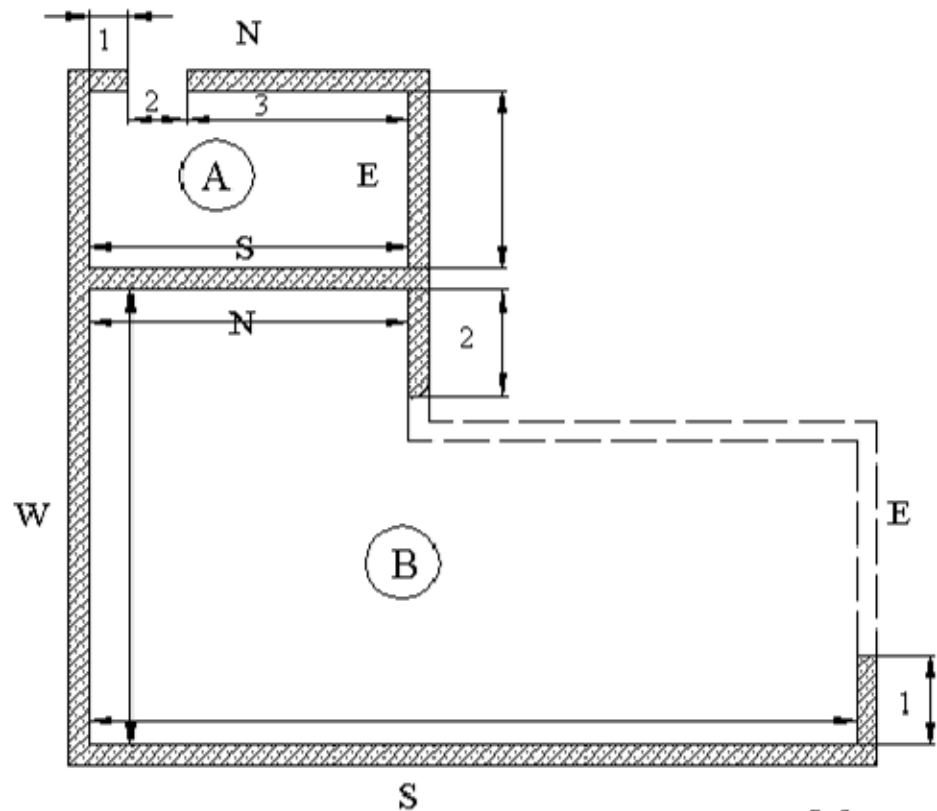
## Ligoniel Corn Mill wall footings plan

From the floor plan it can be seen that the Corn Mill has two distinct sections – a large section to the south and much smaller northern section. In the smaller section the ‘doorway’ stretches over the two stories of the building, from this it could be speculated that this was not actually a doorway, but the location of the waterwheel.
