# Belfast Hills Heritage Survey

SARAH GORMLEY

2013

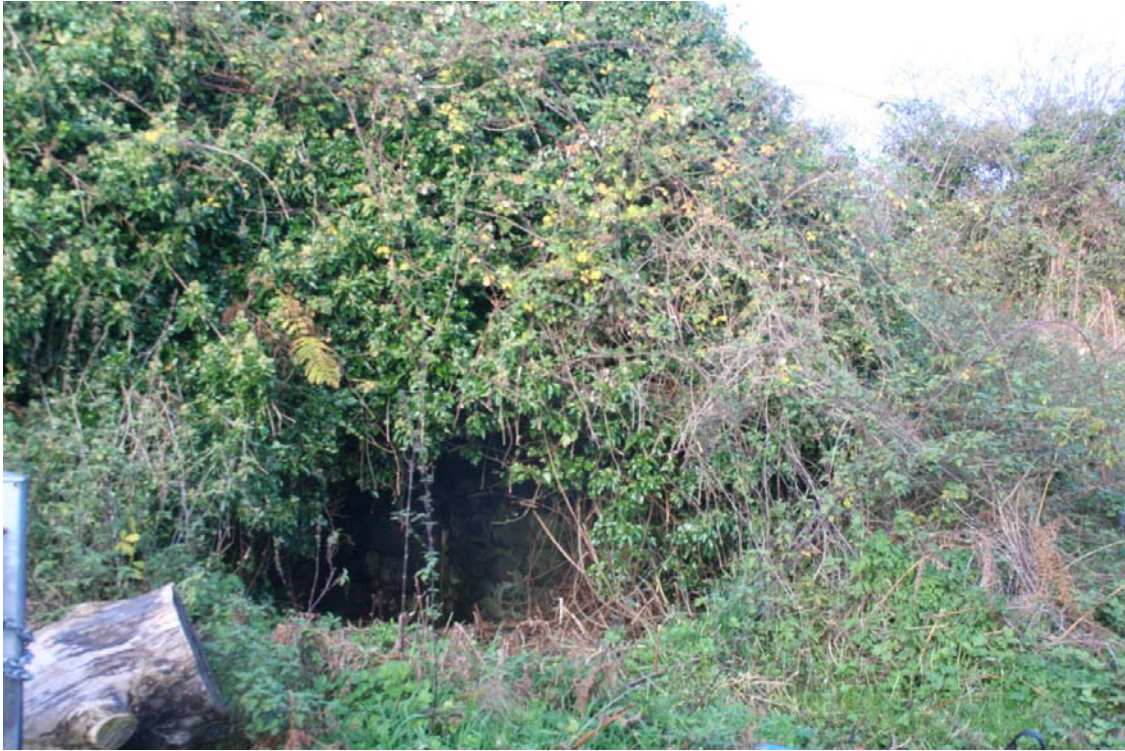
A close inspection of this lime kiln was not possible due to the thick undergrowth (Figure 2.4). The structure is covered in ivy, and further surrounded by a thicket of brambles, nettles and weeds. Prior to the current inspection a small area around the arched recess was strimmed of vegetation and allowed a limited survey of the structure to be carried out.

Figure 2.4 - Duanney limekiln (IHR 1026500000)

The priority for conservation of the structure should be to deal with the vegetation problem. This will, in the first instance, allow for the structure to be more effectively assessed, but will also facilitate making the structure sound. Once the vegetation has been removed it will be necessary to repoint and repair the masonry, where necessary. It would also be pertinent to seal off the furnace shaft to prevent visitors from climbing, or falling in. This has been successfully achieved at other lime kilns, such as that at on the National Trust land at Murlough Bay, Co. Antrim, with the use of a metal grill (Figure 2.10-2.11).

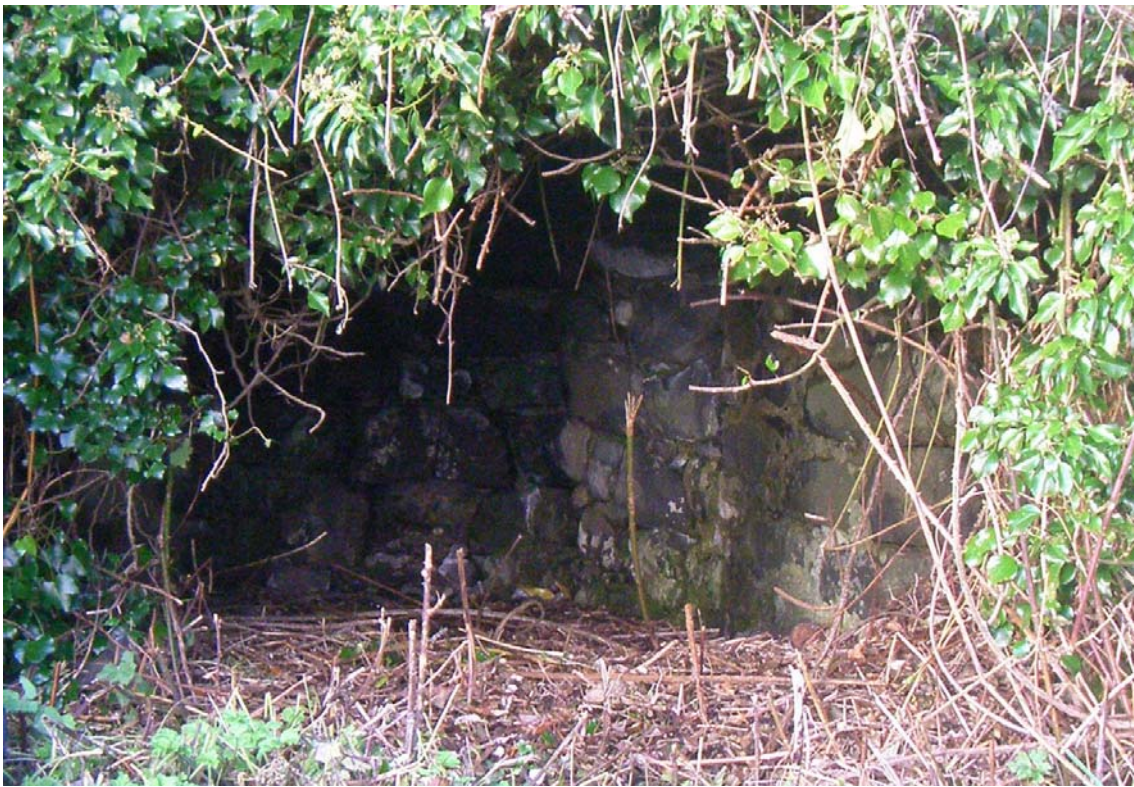
The draw hole is entranced by an arched recess (Figure 2.5), which currently measures 2.36m wide and 2.03m high at the entrance and is 2.4m deep. The recess appears to be constructed using an arch at the mouth which extends into the recess 1.2m. The roofing at the rear of the recess is corbelled. The height within the recess reduces from 2.03m at the entrance to 1.35m at the back. It is likely that the original height within the recess was greater, however, as the build-up of debris and soil on the ground surface within, is likely to have reduced the overall height. The width of the recess reduces from 2.36m at the mouth to 0.8m at the back.

There are three cavities within the arched recess. One, an opening, is located centrally at the back, and measures 0.37m wide and 0.56m deep. The top is 0.33m from the present ground surface. It seems likely that this is where the lime was removed from once fired. Two cavities are located in the walls of the recess. One to the right of the entrance, in the northern wall, 1.16m from the entrance, is 0.8m from the present ground surface and measures 0.4m wide, 0.35m in height and is 0.56m deep. The other, to the left of the entrance in the southern wall, is 1.7m from the entrance and is 0.6m from the present ground surface. It measures 0.23m wide and 0.29m in height and is 0.46m deep (Figure 2.6). Their function remains unclear. A possible vent and stoke hole is located just above the centrally located opening at the back of the recess. This appears as an unmortared gap between two basalt blocks.

Figure 2.5 - Arched recess at Duanney lime kiln (IHR 1026500000).

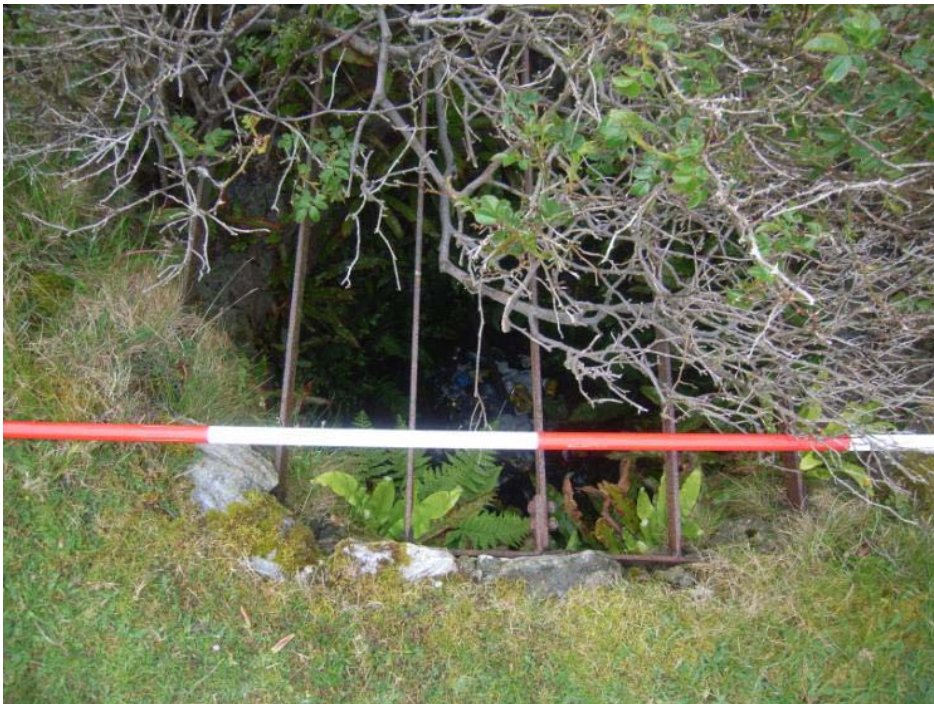
Figure 2.11 - Metal grill covering furnace shaft at Murlough Bay lime kiln (from Welsh 2001, figure 16).

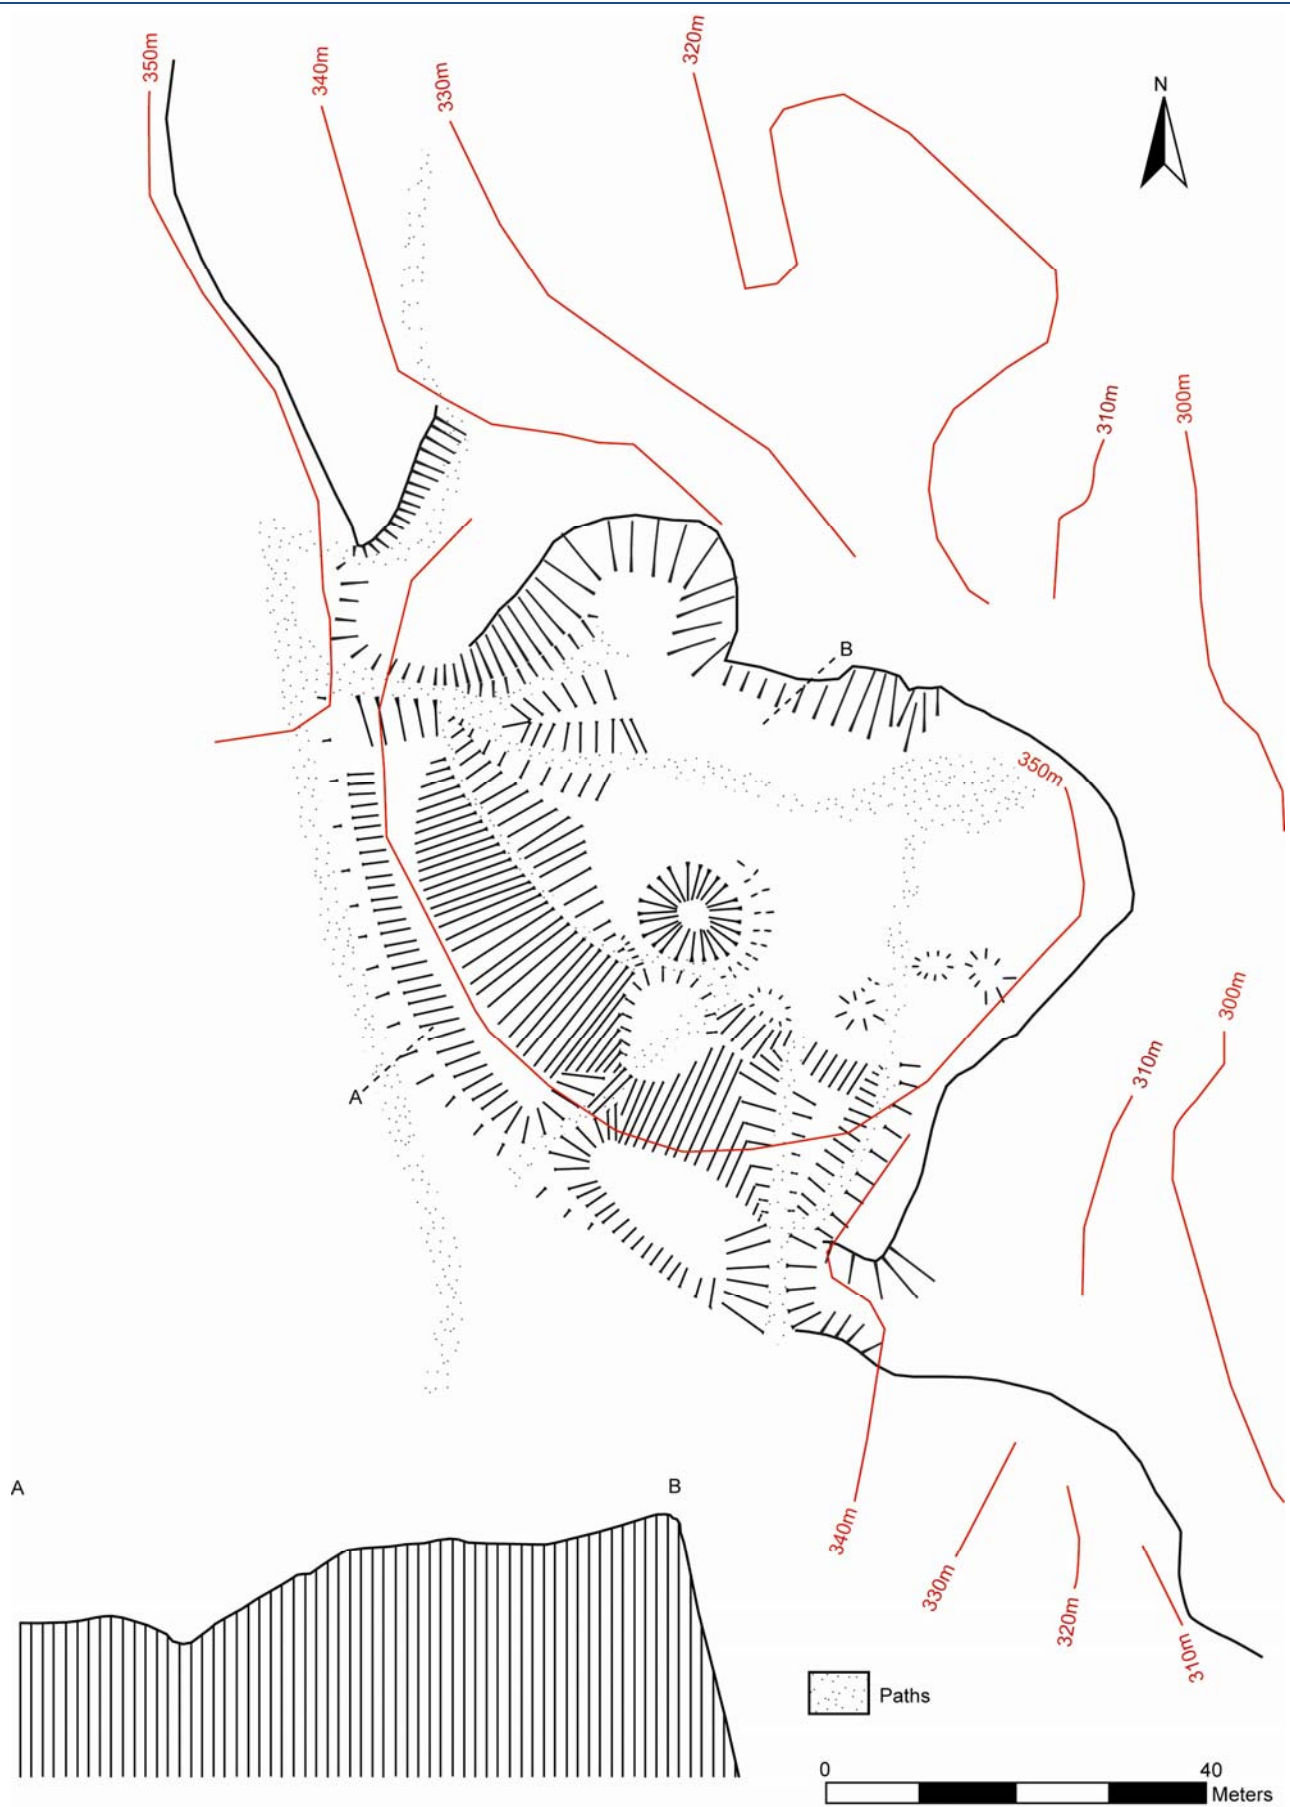
Figure 3.1 – Plan and profile of McArt's fort. After NIEA SMR file (ANT 056:018).

There are three causeways across the ditch (Figure 3.1), allowing access to the interior and steps (Figure 3.4) have been added to the steep slopes. The monument is much crossed with visitor worn paths, which have caused erosion of the monument (Figure 3.5). There is also a large quarried hole on the interior (see Figure 3.1).

It is recommended that an excavation is undertaken, with a trench located across a section of the bank and ditch, to allow for better understanding of this familiar, but enigmatic monument.

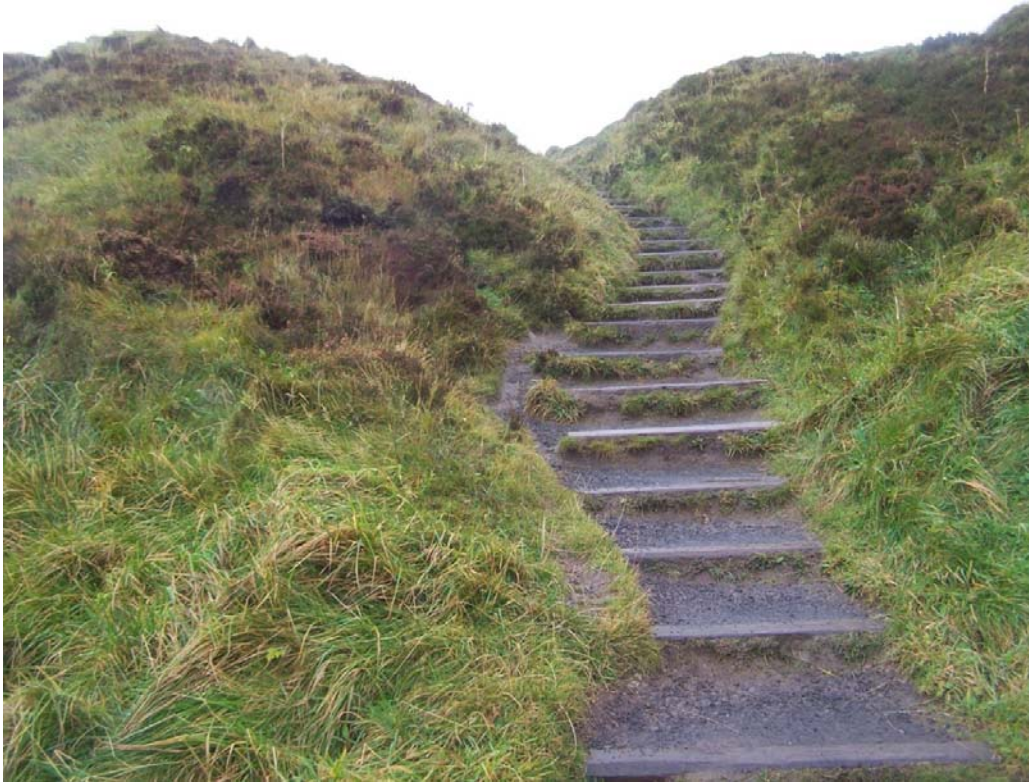
Figure 3.4 – Steps cut into the steep slopes.

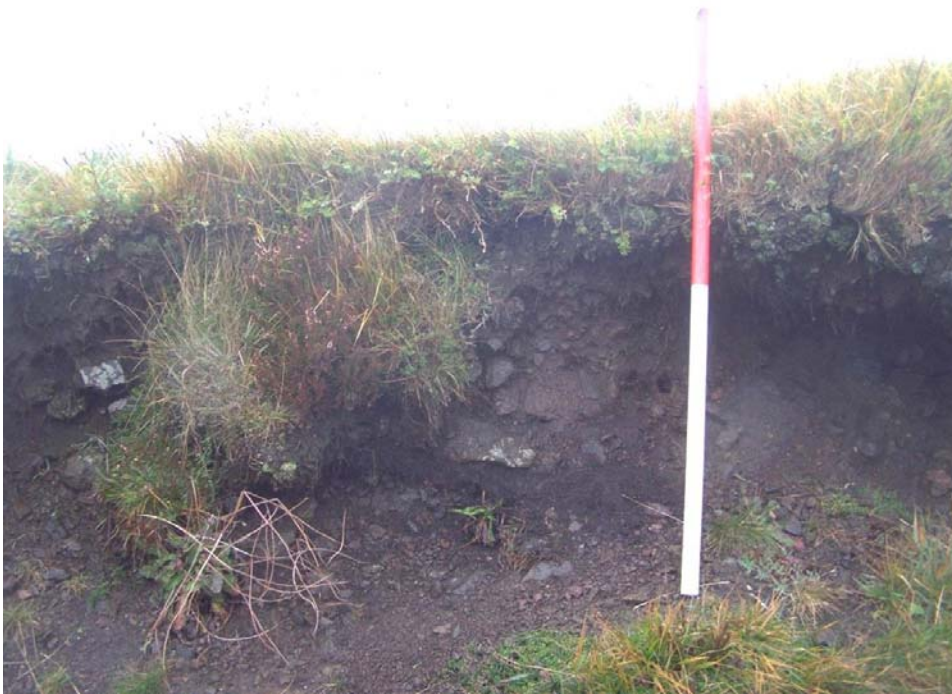
Figure 3.5 – Erosion of the bank.

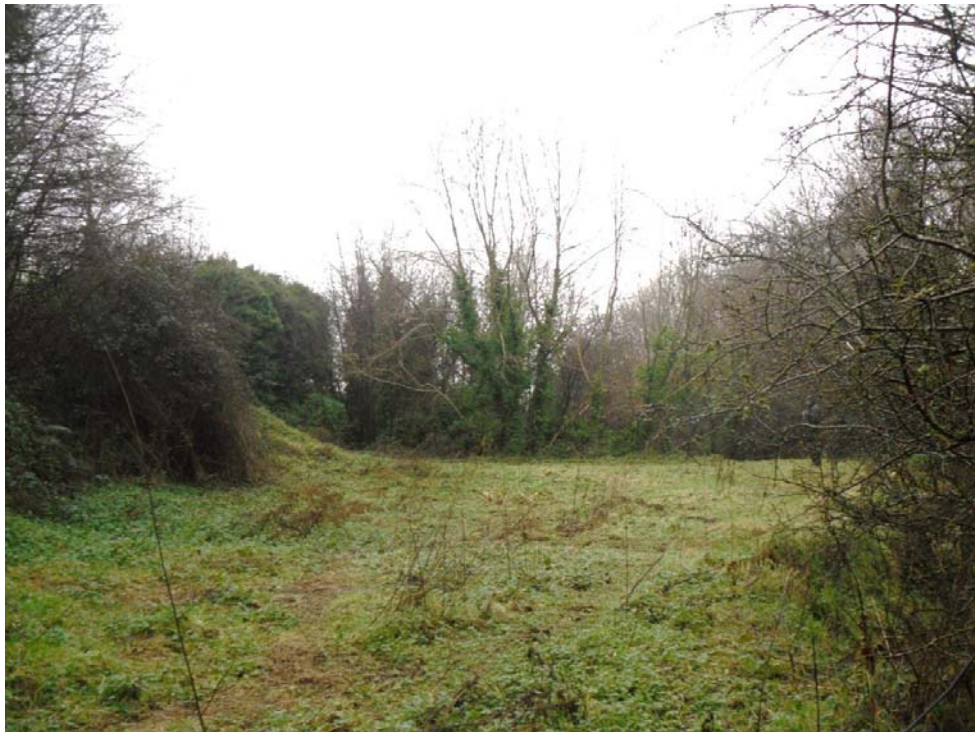
Figure 4.8 – The remains of the mill today, disguised by trees, looking south-south-east (a similar perspective as that depicted in the postcard of 1907, see Figure 4.1 above).

It is recommended that the mill site is made safe and presented to visitors to the park.

Make safe the mill building:	Erect hoarding around the works.	
	Remove trees, shrubs and tree stumps.	
	Erect scaffolding and dismantle gable wall to 0.90m above ground.	
	Excavate to expose remaining mill walls.	
	Remove all from site.	
	Clean out joints and repoint remaining walls with lime mortar and cap with an in situ lime mortar coping (as per NIEA guidelines).	
	Excavate for and concrete to foundations and fit a steel grill to cover 15.00 x 4.00m wheel pit.	
		£37,000.00 plus VAT
3D Laser scan of the elevation		£500

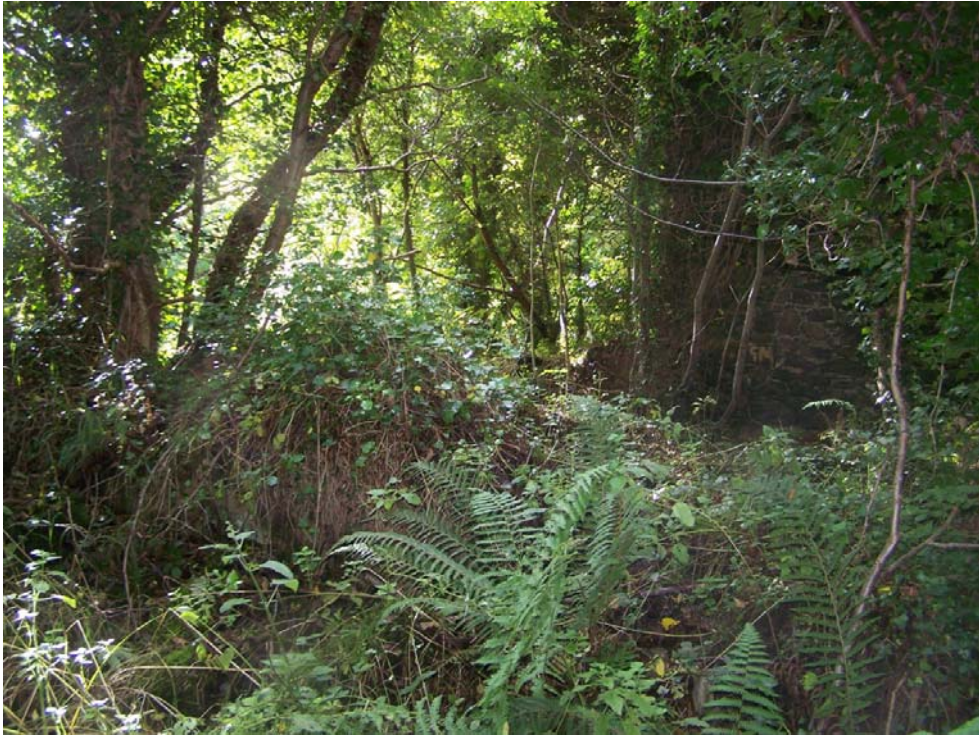
Figure 4.9 - Remains of the mill gable today, looking south-south-west across the wall-footings of the houses.

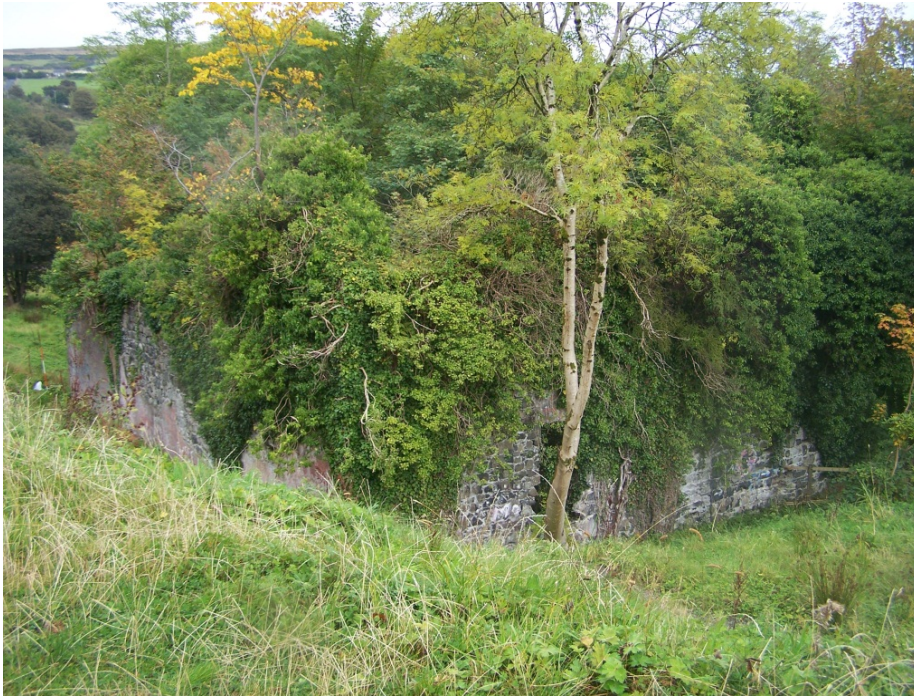
The mill building at Wolf Hill presently stands between two large mill ponds within an amenity area in Legoniel townland (IGR J29477 77538). The building, now ruinous and largely obscured by trees and bushes (Figure 5.1), may have its origins in the late 18<sup>th</sup> century and later formed part of the large mill complex of Wolf Hill Spinning Company which was operational until the 1960s. Legoniel was once a thriving industrial area, particularly important for linen manufacture and this building, the remnants of the adjacent bleach green and the two mill ponds are the last survivors of the works at Wolf Hill. For the current study, the building is described and placed within its wider historical context and its potential as a community resource has been explored. Conservation needs have also been highlighted.

Figure 5.1 - Wolfhill cornmill, from the bank of the upper mill pond, looking north east.

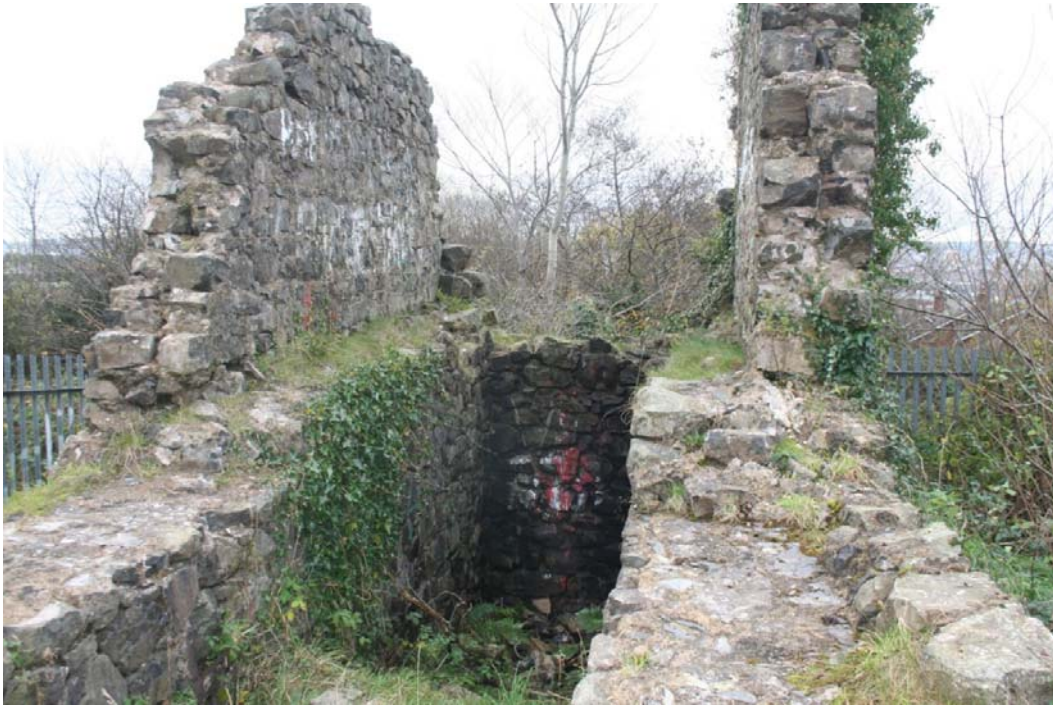
On the lower slopes of the Black Mountain, the remains of the wheel pit and the outline of the mill building are enclosed within steel fencing on derelict land on the edge of housing development. The remains are barely visible in trees and bushes (Figure 6.2). Graffiti, dumped rubbish and the remains of bonfires have left the mill and wheel pit in a rather dilapidated and sorry state. The stone built remnants of the wheel pit are the most apparent remains visible (Figure 6.3) and measure around 13.9m east-west and 3.3m north-south. The remains of the mill building are less apparent and can only be discerned as a sub-rectangular hollow measuring approximately 16.7m north-south and 6m east-west.

The remains of the wheel pit appear to be in a fairly robust condition; however, given the dereliction of the immediate surroundings, it is difficult to determine the condition of any other associated remains.

Figure 6.3 – The wheel pit, looking east.

This site has interest, particularly given that the remainder of the works associated with the Whiterock bleach green have now been encroached upon by the urban expansion of Belfast. The immediate surroundings, however, make the study and exploitation of the remains untenable, at present. The issues, such as dumping and anti-social behaviour would need to be addressed before the potential of the monument could be realised. Clearing the monument of vegetation, for example, might only serve to attract further unwanted attention and any such conservation would need to be accompanied by a larger programme of works improving the immediate derelict landscape.

Overall, if the area of land on which the wheel pit sits could be improved in order to be used as a recreational space, the industrial remains would add value to such a scheme. Clearing the vegetation from around the works would also allow for a more detailed survey to be carried out.

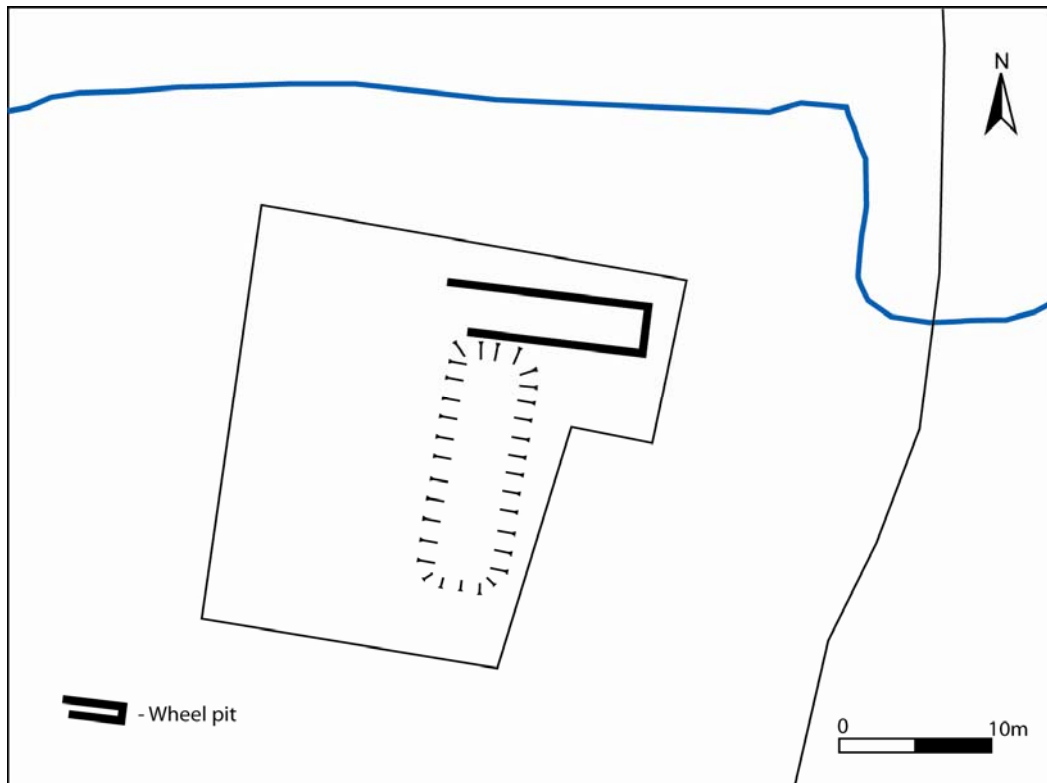
Figure 6.4 – Outline of the wheel pit and mill building, within the steel fencing. The fence line of the housing estate is depicted immediately to the east and the stream runs immediately to the north.

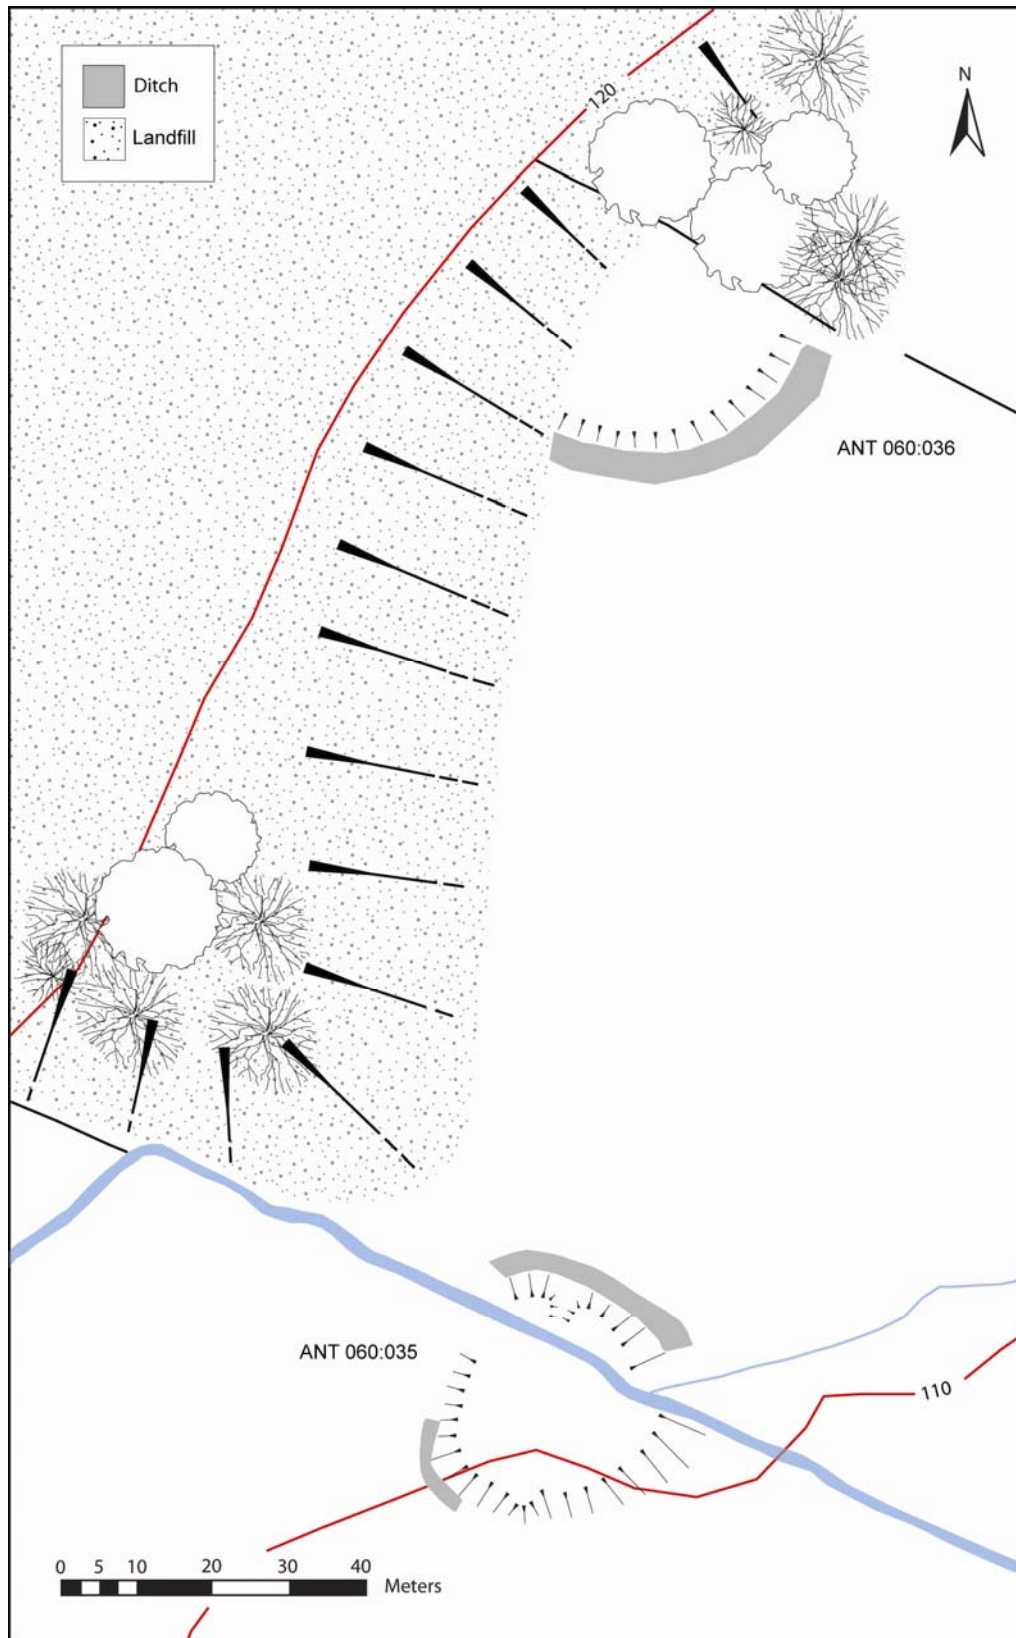
A topographical survey of the two raths was undertaken using a Leica TPS 705 Series Total Station and was processed using Leica Liscad software. The plan (Figure 7.3) shows the raths and the commercially dumped landfill material which has encroached on the northernmost rath (ANT 060:036).

Figure 7.3 – Plan of Ballymurphy raths.

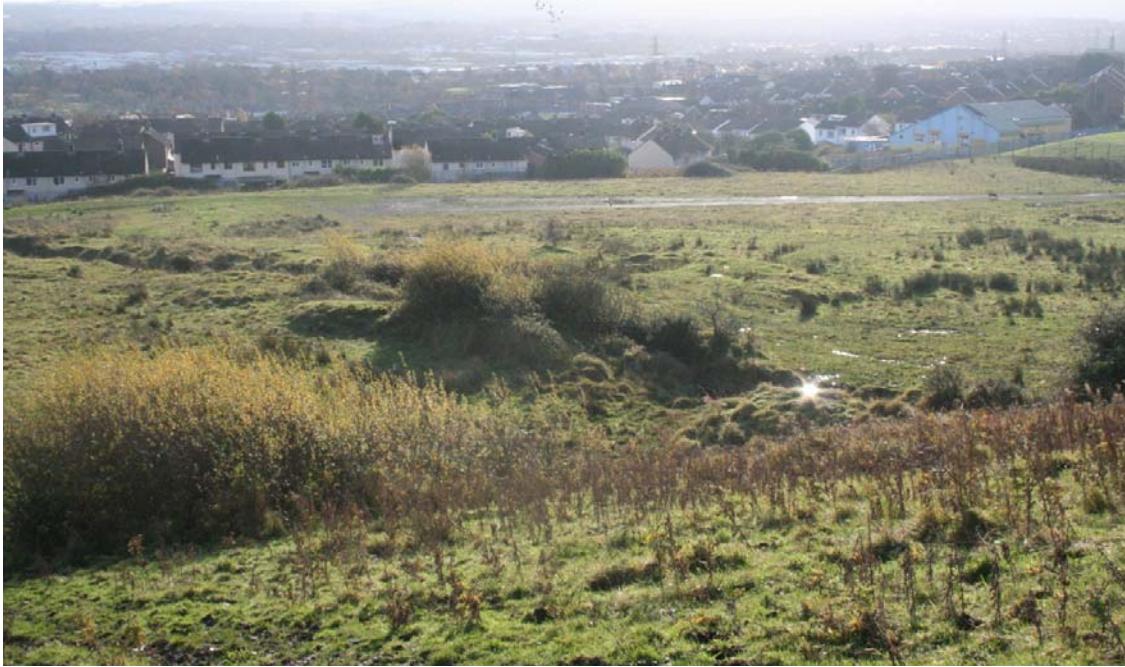
The southernmost rath (ANT 060:035) was bisected by a mill race associated with the Whiterock Bleach Green. The mill race is depicted on the first edition OS map of 1833. The rath was further damaged by a bulldozer when a playing field was being constructed nearby in the 1970s. The current appearance of the irregular perimeter and the uneven surface of the monument would suggest that significant damage to the underlying archaeological layers has been done. There are also recent scambler tracks running over the monument which will further affect its condition and survival if left unchecked.

Figure 7.4 – Ballymurphy rath (ANT 060:035), from the tip heap, looking south-south-east.

Outside of improving the surrounding area, there would appear to be no current conservation needs specific to the raths themselves. Damage is being caused to the southern rath by scambler tracks (ANT 060:035) and should be discouraged, although while there is easy access to this area from the Upper Whiterock and Ballygomartin Roads it is difficult to see how this could be achieved. Fencing the monument would not be recommended as it would lead to the rath becoming overgrown.

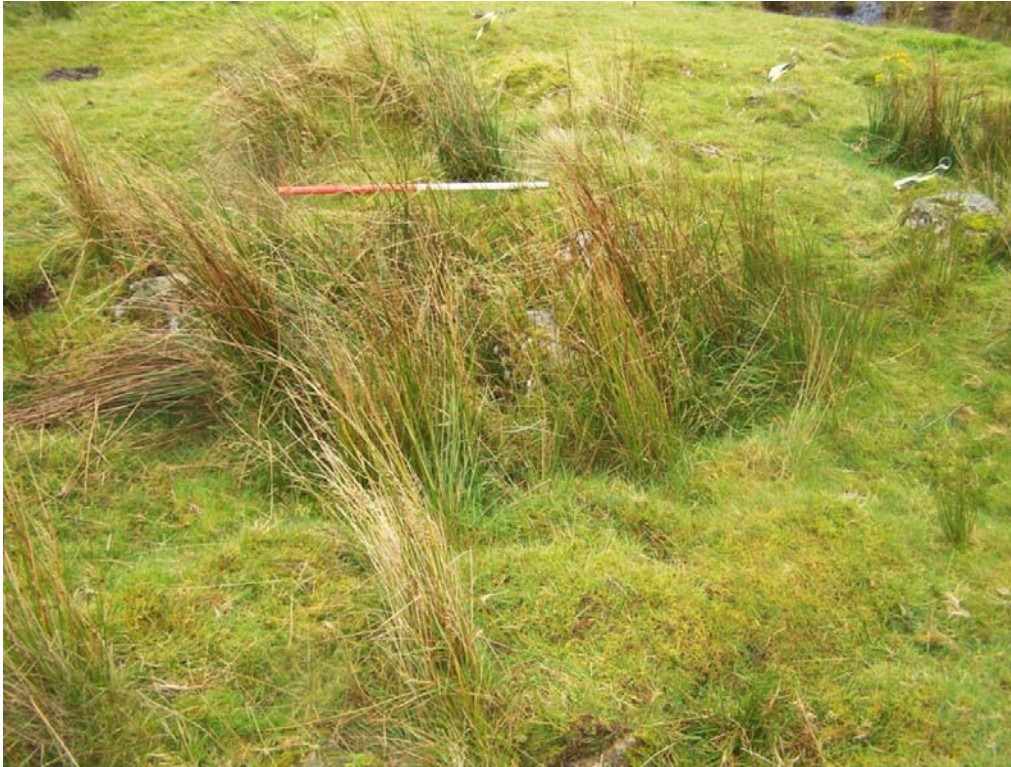
The huts are in good condition and no conservation requirements have been identified. The current management regime of light grazing is serving to preserve and protect the hut sites.

Figure 8.6 – Hut 3, looking south-west.

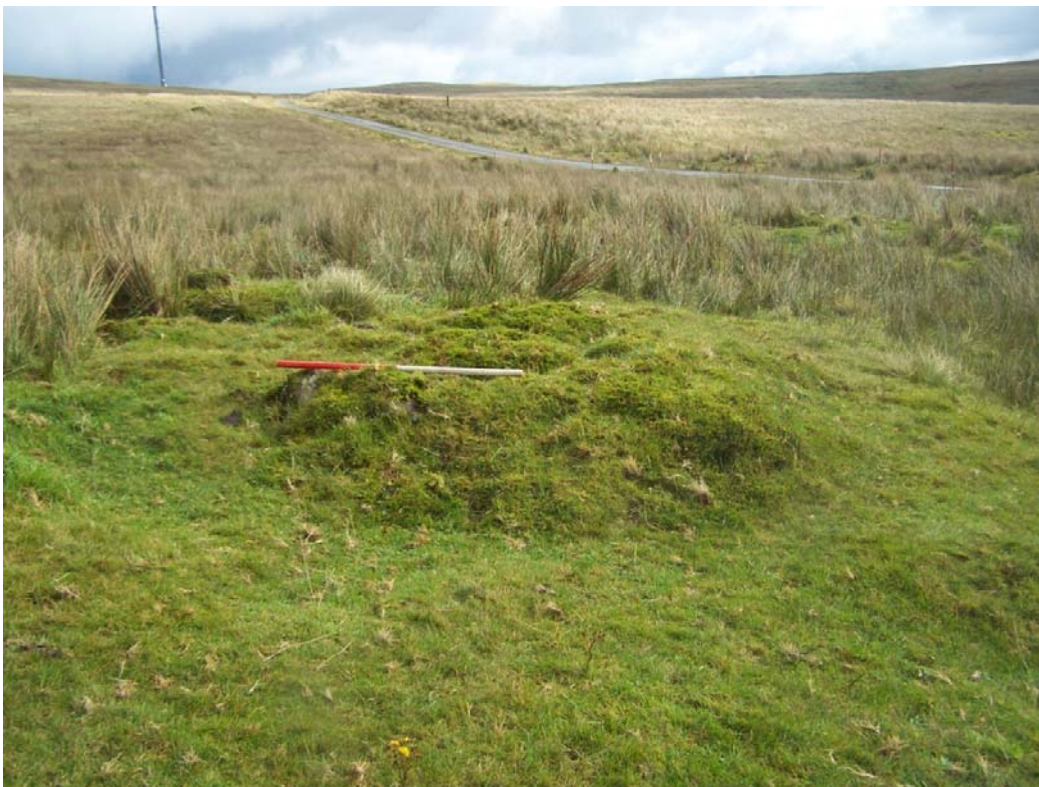
Figure 8.7 – Hut 6, looking east.

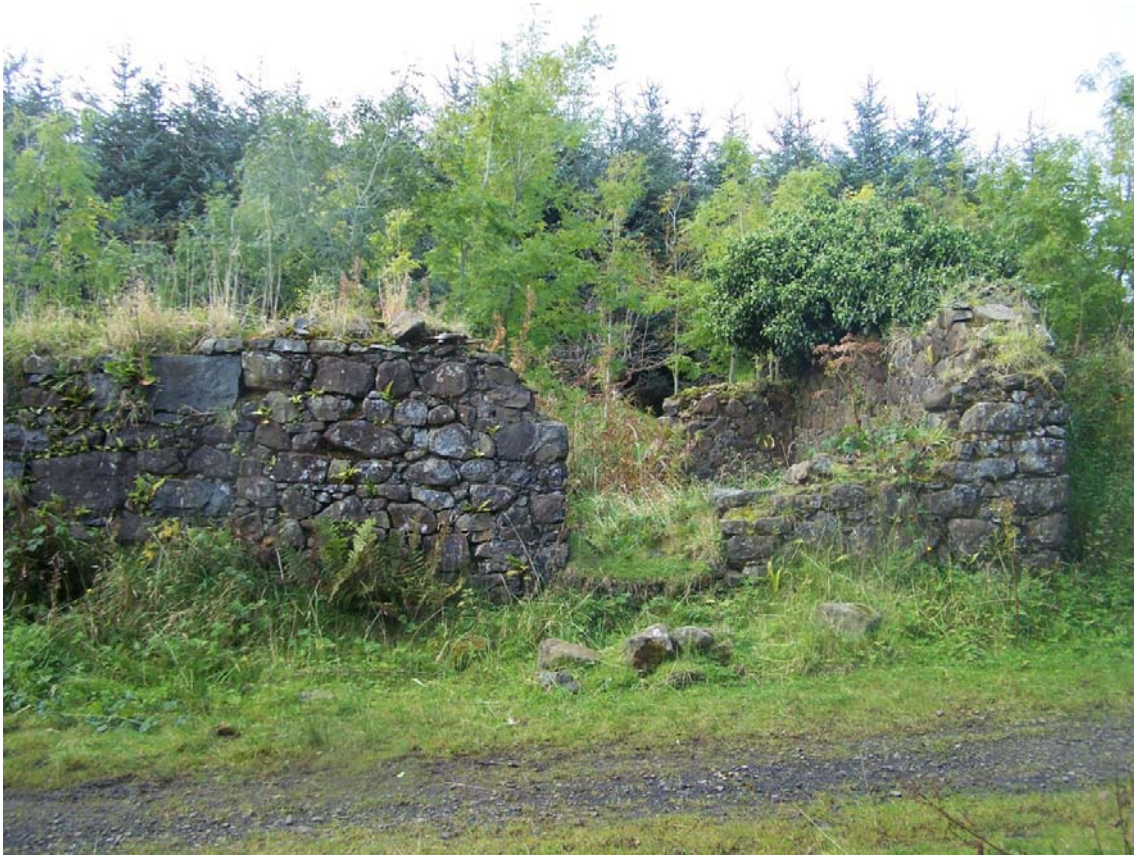
A single unroofed structure, constructed of sub-angular basalt boulders, is visible on the site today measuring 27.5m north-north-east to south-south-west and 5.8m west-north-west to east-south-east, with wall between 0.5m-0.7m wide (Figure 9.2). The walls stand variously between 0.5m and

Figure 9.2 – Glenside woodland farmhouse, looking north-north-west.

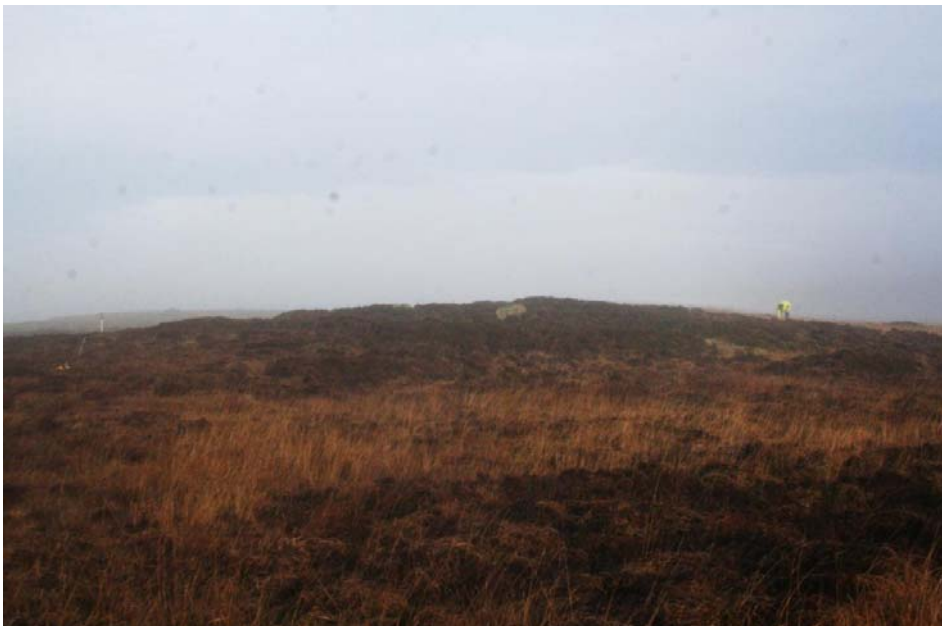
A second cairn (likely to be ANT 064:027) is described as a being located a short distance to the north of ANT 064:001 (Figure 10.3). The OS memoir notes that it is circular and is 12.8m in diameter, standing 1.2m high (Day and McWilliams 1991, 97). A row of large stones is described around the base 'a few of which still remain undisturbed' but the cairn is pronounced 'greatly destroyed'. A standing stone (ANT 064:028) is detailed, 6.4m north of the cairn, standing 1.17m tall and 0.6m across by 0.46m thick with a large stone lying beside it. A further two smaller standing stones (ANT 064:029) were reportedly located on the south west side of the cairn, one 0.68m high and the other 0.46m. The cairn is further described in the SMR (dated July 1994) as a poorly preserved round cairn, overgrown with heather and measuring 19.1 N-S by 18.5m. In total 11-14 possible kerb stones were identified in an arc running from west, through north to east-north-east. The SMR notes that the

Figure 10.3 – Cairn (ANT 064:027), a low heather covered rise, looking north.

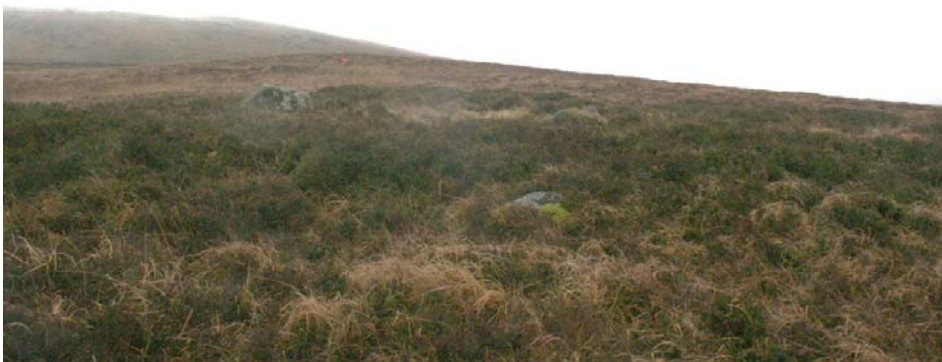
Figure 10.9 – The cairn, looking south-west, with a kerbstone visible in the fore ground and the two uprights beyond, possibly in their original position.

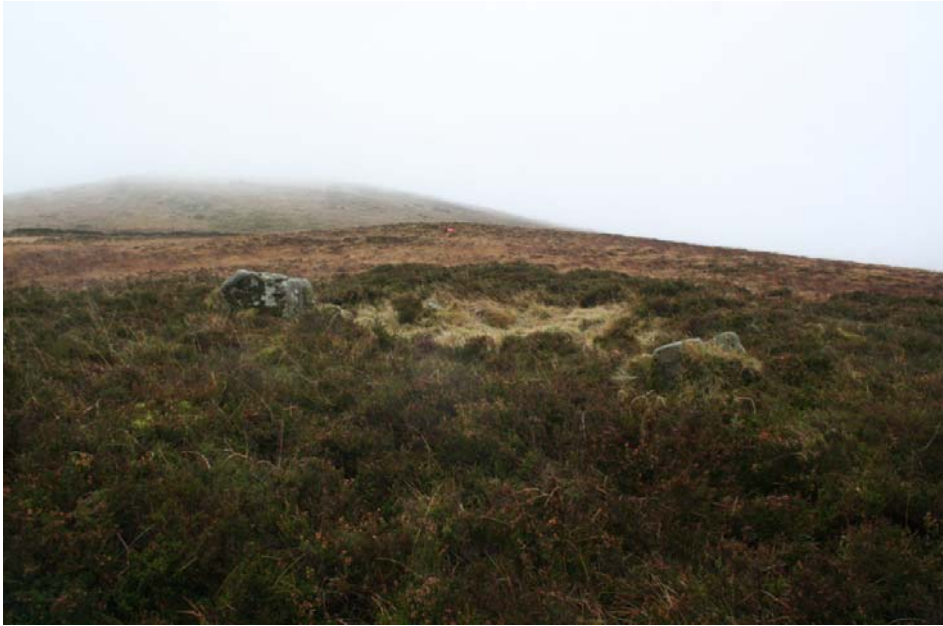
Figure 10.10 – The cairn, looking south-west, across the quarried interior, two upright stones are visible.

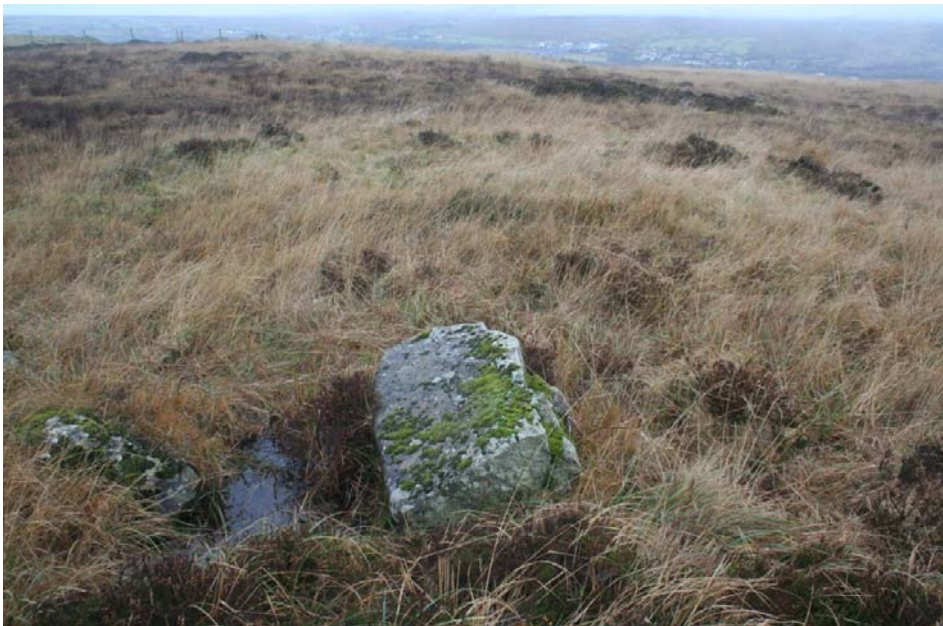
Figure 10.11 – Recumbent slab, from the cairn, looking north-north-east.

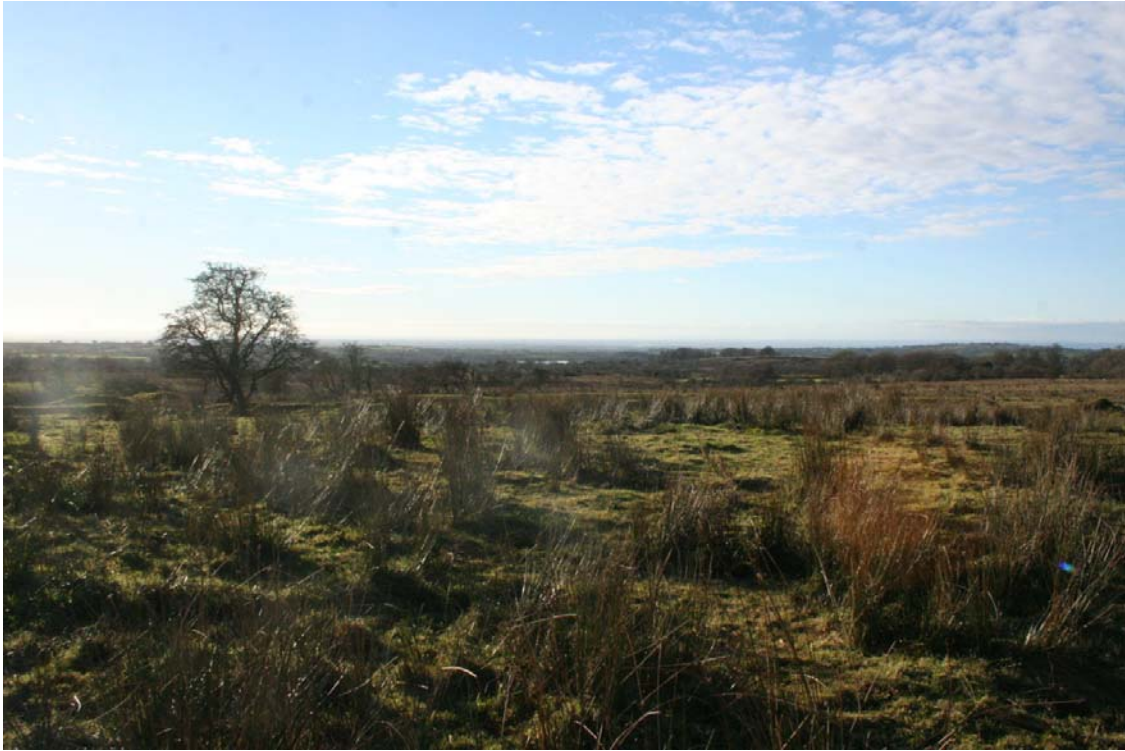
Figure 11.2 – Looking south-west across the interior of the enclosure.

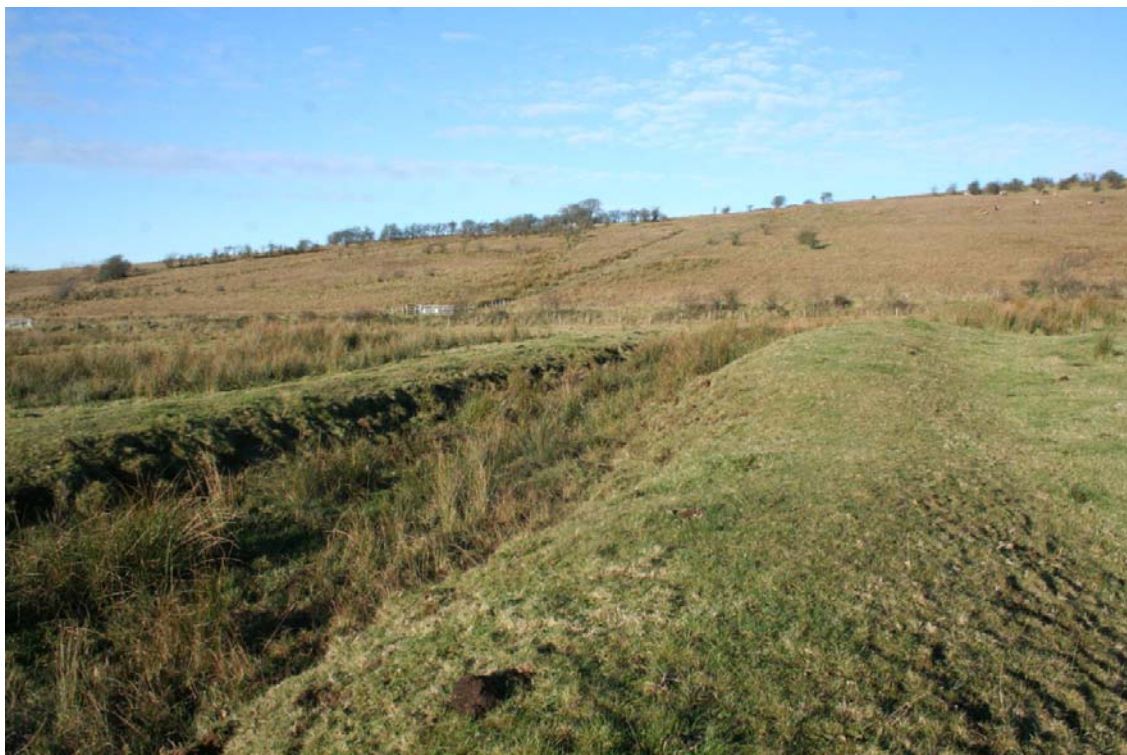
The large enclosure remains much as described by previous writers. The interior measures around 95m north-south and 105m east-west and is enclosed by a bank and outer ditch (Figure 11.5). The bank is preserved less well at the north (where there are no signs of a ditch; Figure 11.6) and measures around 4m wide and 0.5m high at this side. To the west and south the bank is better preserved and is over 4.5m wide and 0.5m above the interior and 1m above the ditch. The ditch is 3.5m wide, but is absent at the north. There are traces of a second, outer bank from the north-west through west and south to south-east. It is up to 2m wide and is 0.2m higher than the ditch and stands 0.35m above the exterior ground surface. There are a number of breaks in the banks and the

Figure 11.5 – Bank, ditch and outer bank at the west side, looking north.

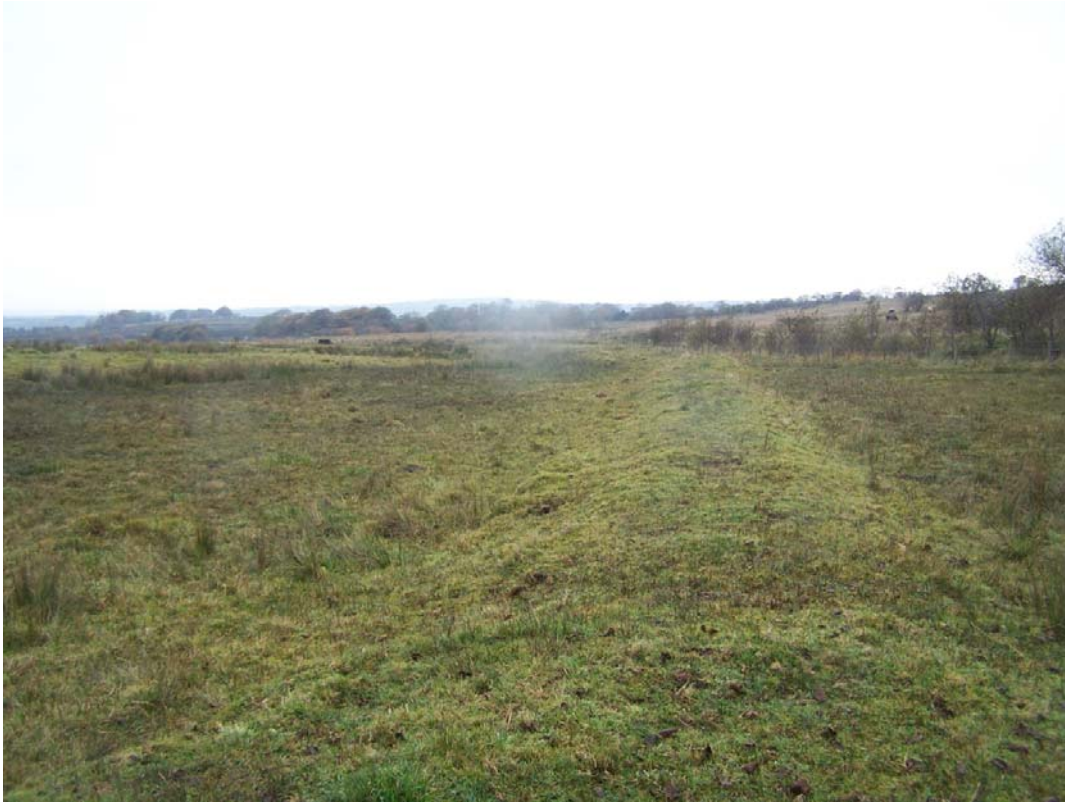
Figure 11.6 – Bank at the north, looking west.
