# Belfast Hills Heritage Survey

SARAH GORMLEY

2013

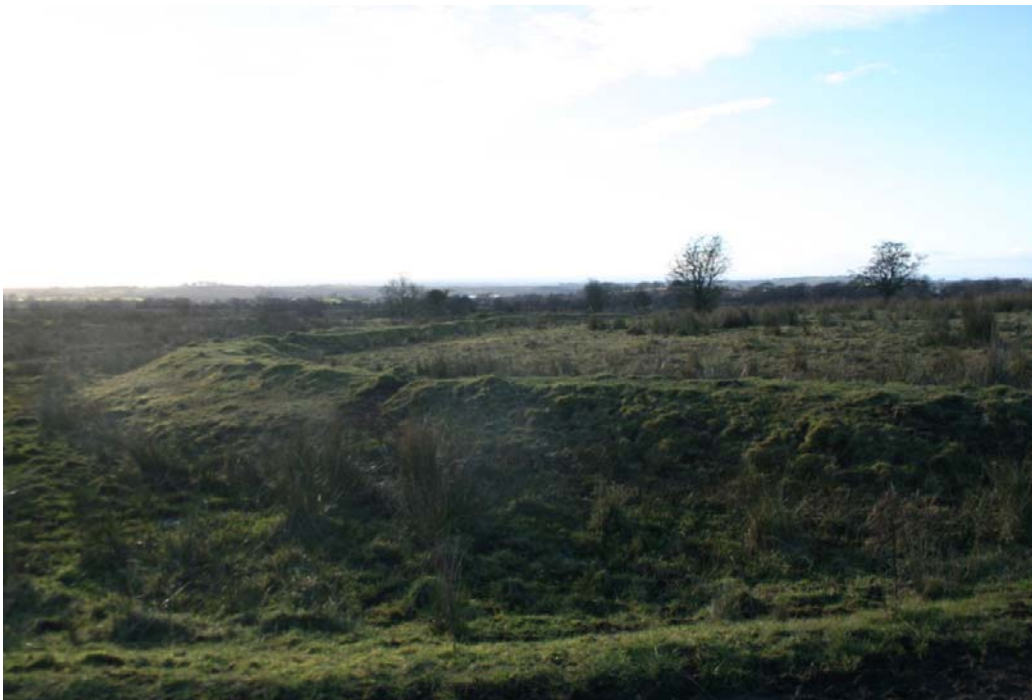
enclosure has been modified at the eastern side with the construction of a laneway (Figure 11.7). A field boundary crosses the monument from north-west to south-east (Figure 11.8). The level of the interior of the enclosure falls off naturally to the south and south-west and the rush covered interior rises in the centre (Figure 11.9). There is a hint of some internal features towards the north of the enclosure (see Figure 11.4), which may be wall footings, however, these are not definable and further work, such as geophysics, might serve to elucidate this further. There are two further earthworks which may be associated with the large enclosure. They are a platform 30m to the south-east (Figure 11.10) and two linear stretches of bank 20m to the south-west. The sub-rectangular platform appears to be constructed of earth and stone and measures 28m north-north-west by south-south-east and 23m south-south-west to north-north-east and stands around a metre above the surrounding ground and is highest at the south-west. The platform appears to have been modified at the north where it joins the laneway and there is no sign of the 'parapet' described in the Memoirs as 1.5m high and 5.2m wide, or of the ditch. Around 20m to the south-west of the large enclosure are two linear sections of bank, around 5.5m wide and 1.5m above the surrounding ground level. One is aligned north-south and is 20m long. The other runs east-west and measures 10m long.

Figure 11.7 – The south-eastern side of the enclosure was levelled during the construction of a farm lane, looking south-west.

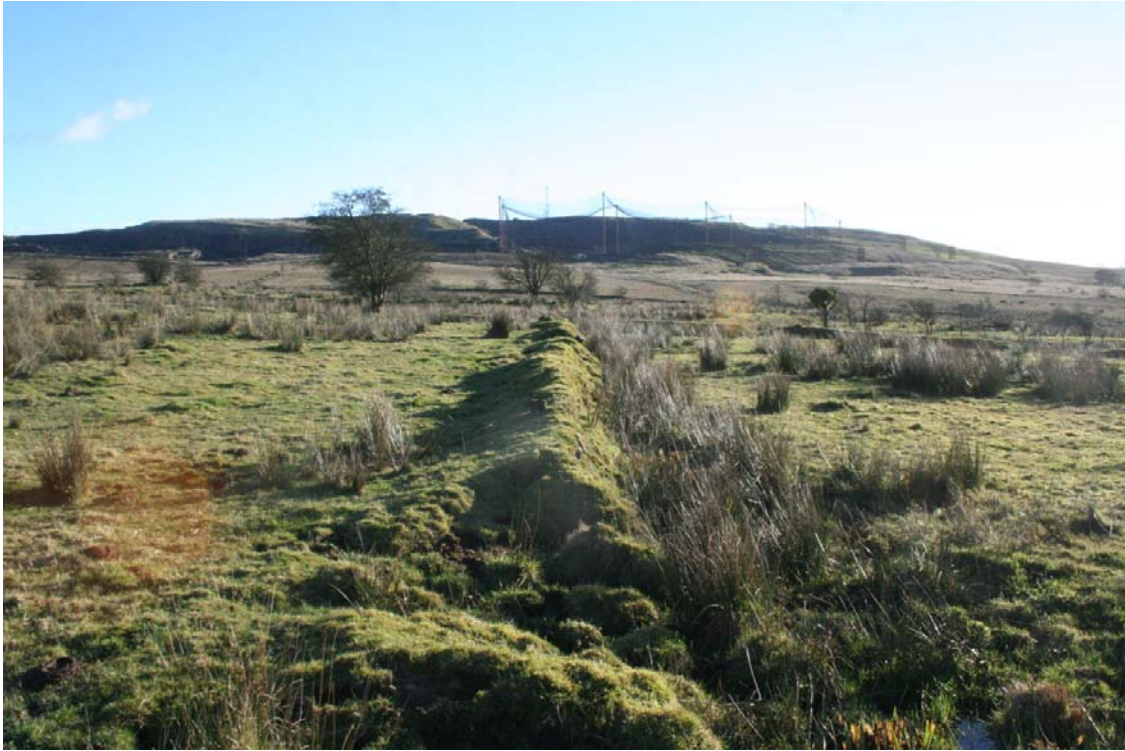
Figure 11.8 – Field boundary which runs across the earthwork, looking south.

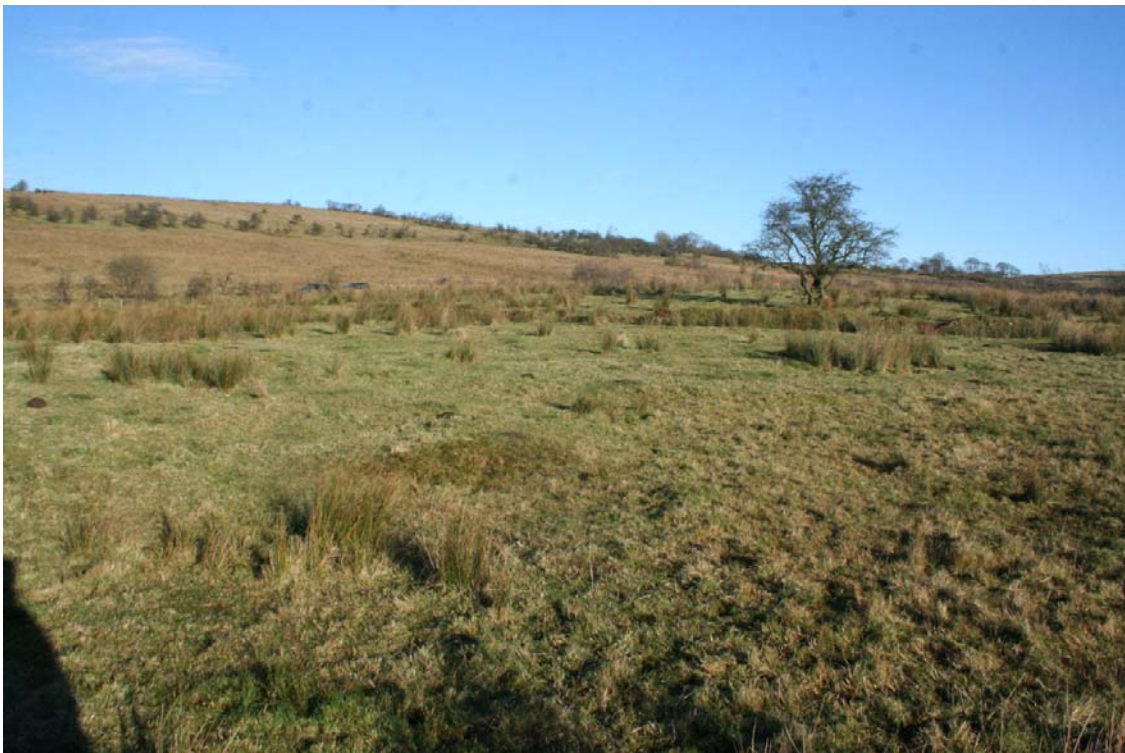
Figure 11.9 – From south-west the level of the interior rises to the centre. Looking across the interior of the enclosure to the north-west.

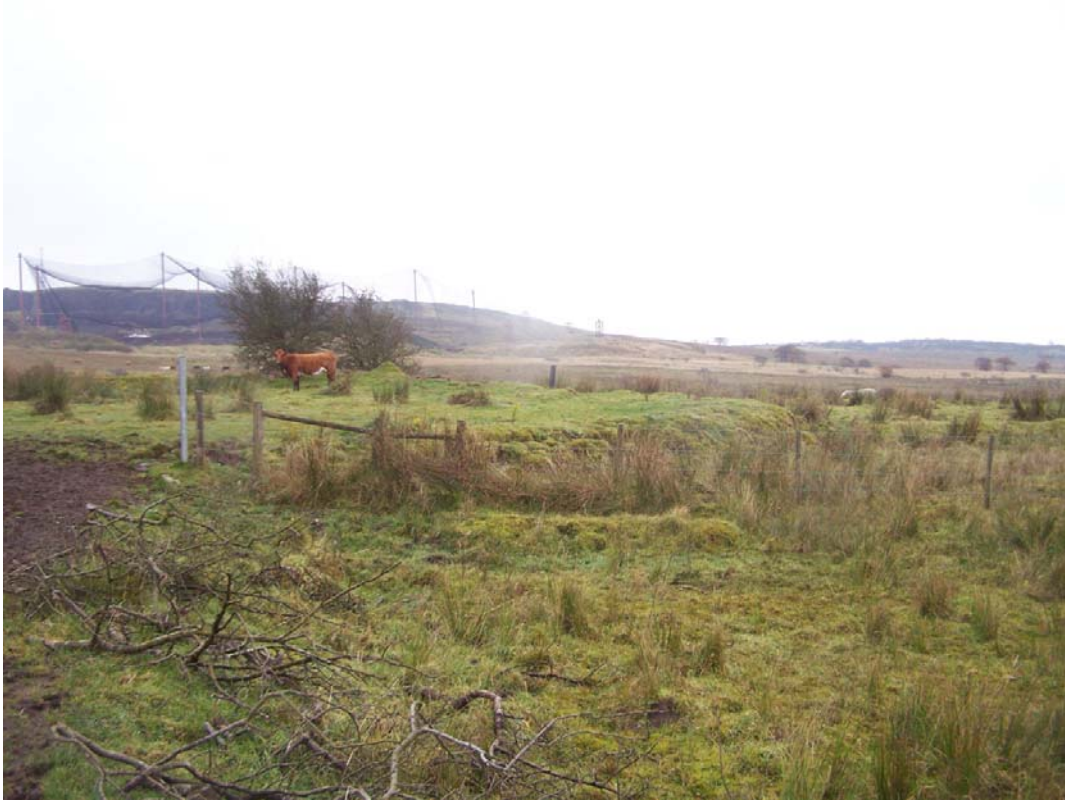
Figure 11.10 – The platform to the south east of the enclosure, looking south east.

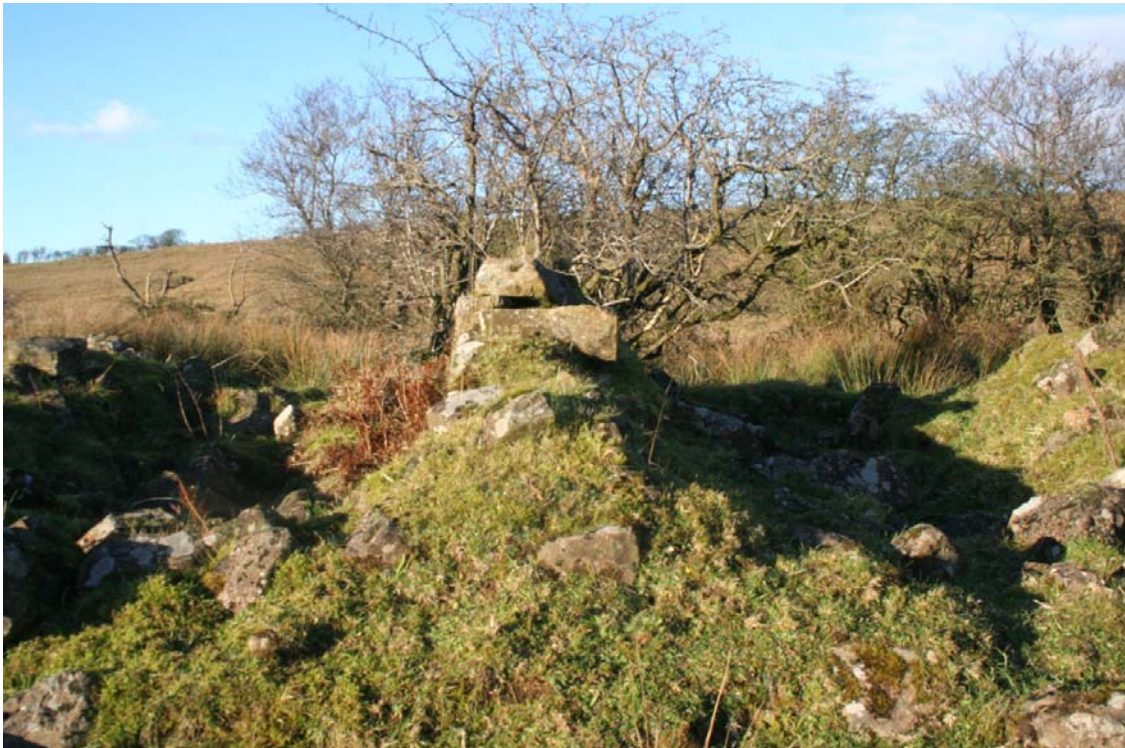
Figure 12.7 – Dividing north-south wall, looking north.

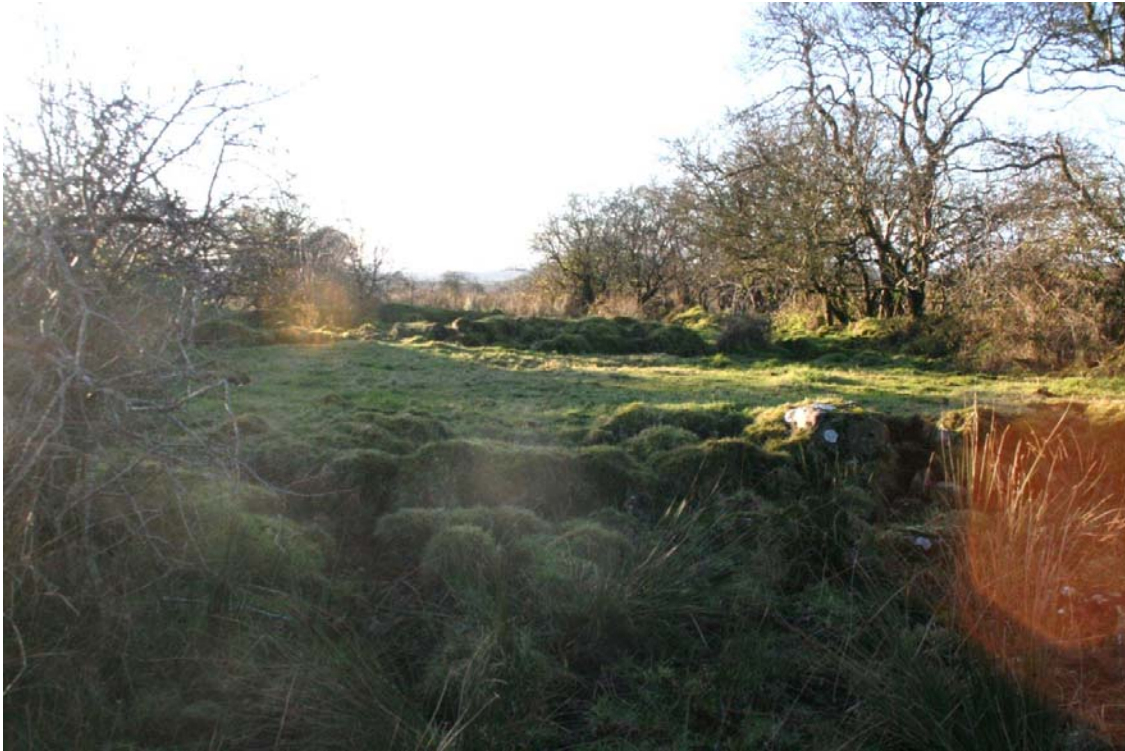
There are four enclosures attached to the rear, which have remained the same since at least 1833 (Figure 12.8). They measure around 20.7m x 25.4, 20.5m x 24.7m, 17.4m x 10.8m and 13.9m x 14.2m. The enclosing walls now survive around 0.7m wide and up to 0.5m high (Figure 12.9). The fields surrounding the ruin are crossed with lazy-beds, evidence that this marginal land was cultivated in the past, perhaps for potatoes (Figure 12.10).

Figure 12.8 – Looking west across the enclosures at the rear of ruin.

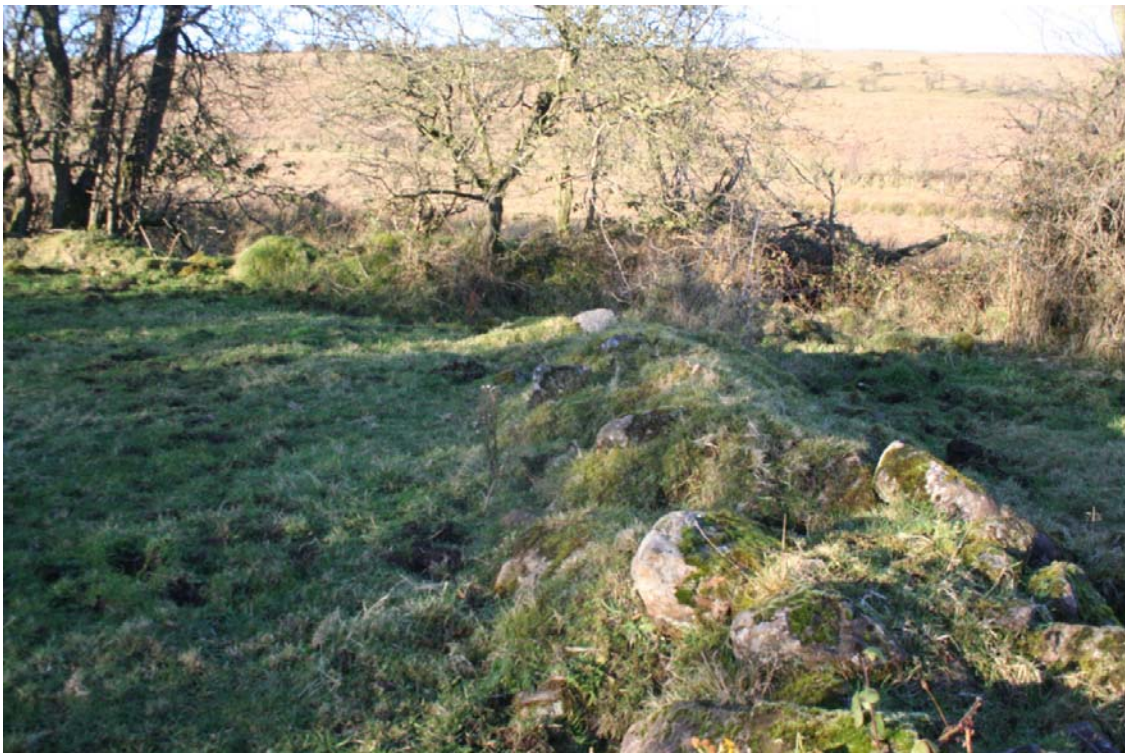
Figure 12.9 – Remains of the enclosure wall, looking north.

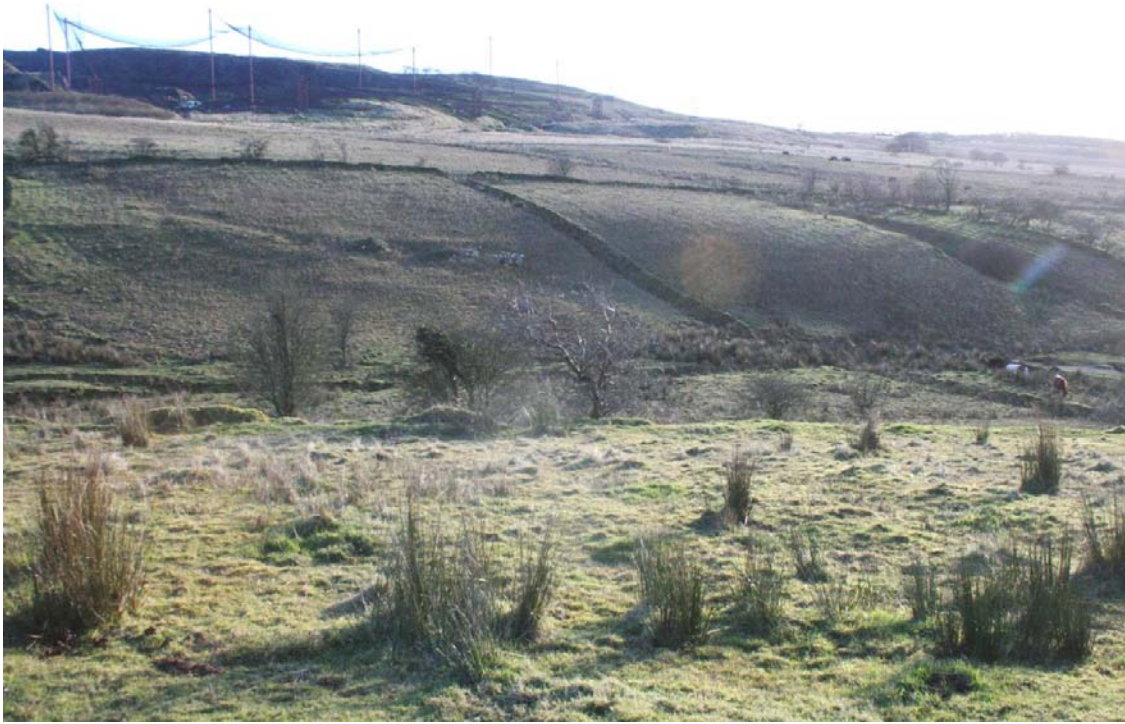
Figure 12.10 – Looking south from the building, lazy-beds are apparent in the surrounding fields.
