Data Structure Report: No.106

Dunanney vernacular house and lime kiln,

Carnmoney Hill, Co. Antrim

CAF DATA STRUCTURE REPORT 106

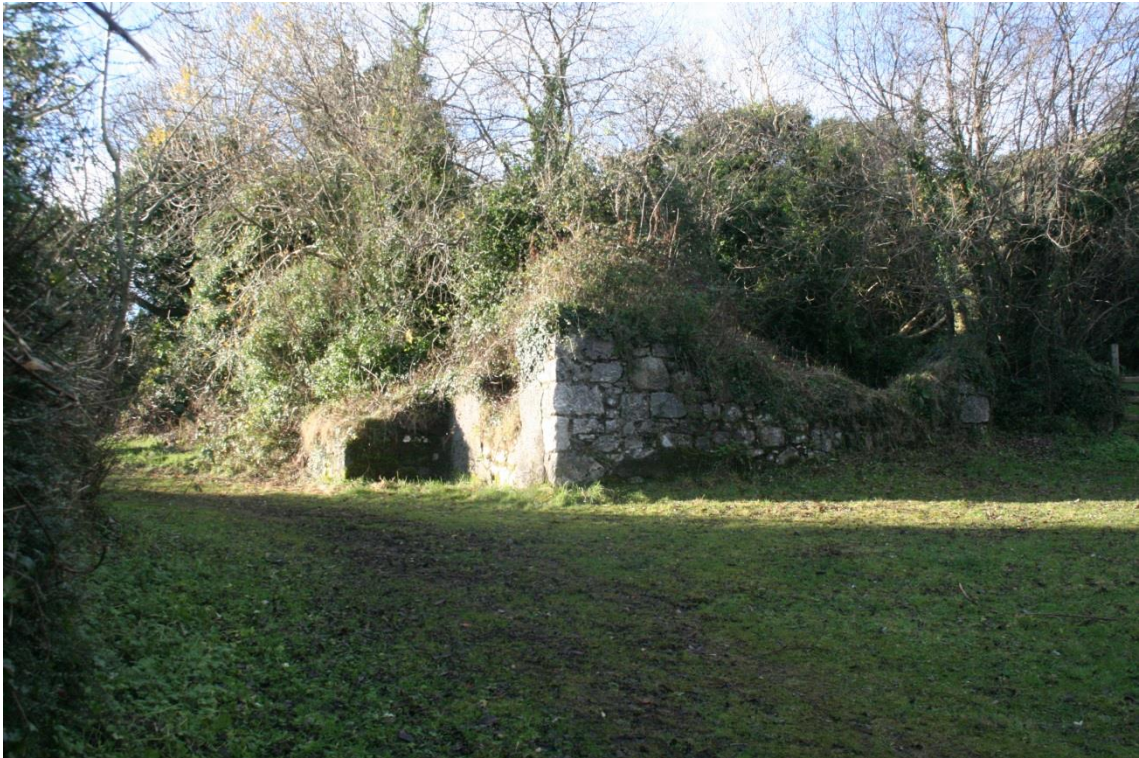
Figure 2: Collapsed and overgrown remains of the vernacular house in 2013, looking west.

Dunanney farmhouse and lime kiln are located in Dunanney townland on the steep slopes of Carnmoney Hill within the Woodland Trust amenity on Newtownabbey Borough Council land. They have far reaching views to the north and east across Belfast Lough and to Cave Hill at the south (Figure 8). The farmhouse and outbuildings are set around a farmyard on Dunanney Lane adjacent to a quarry face at the 130m contour mark. The lime kiln is also on the lane, downslope from the farm at the 90m contour (see Figure 1). At some time in the past the farmhouse had been reduced to rubble and anyone using Dunanney Lane would have walked within a few metres of the kiln without realising it was there, so overgrown were the weeds and bushes around the structure (see figures 2 and 3).

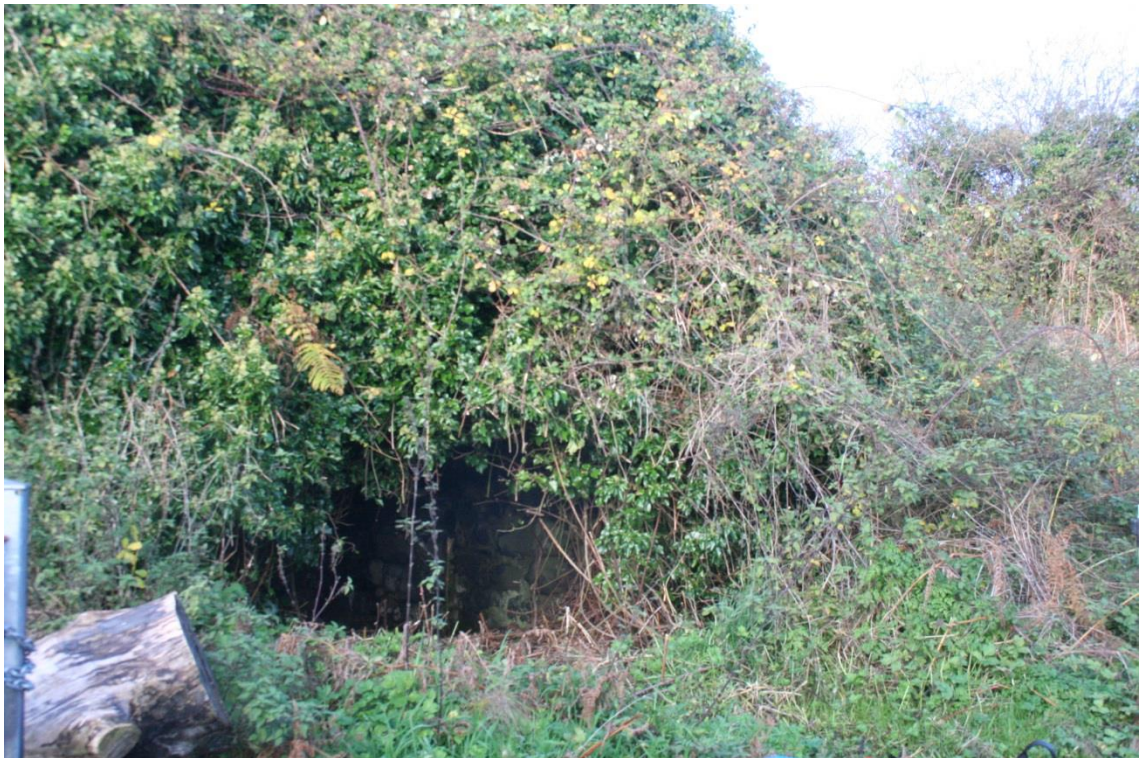
Figure 3: The overgrown remains of the limekiln in 2013, looking west.

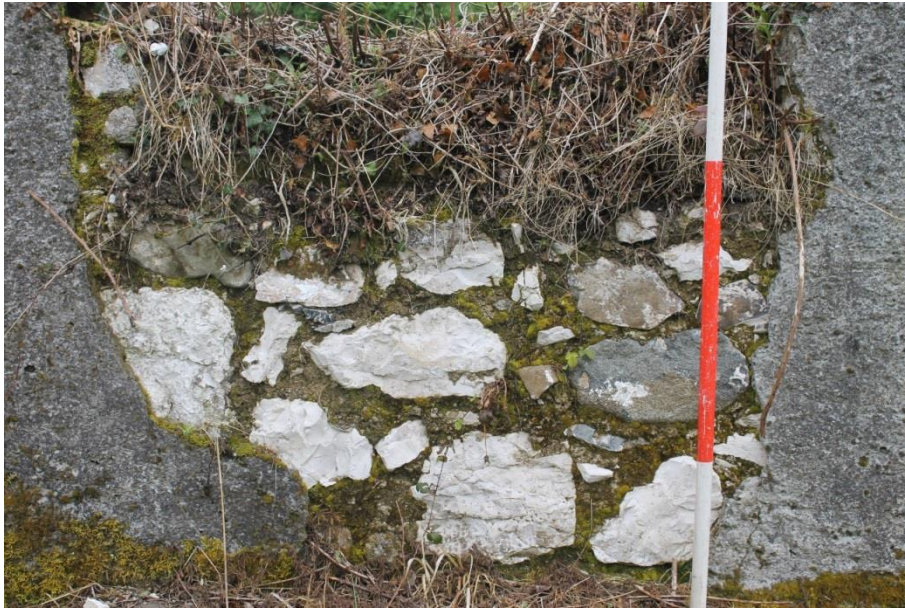
Figure 10: Lime and basalt in front façade of the vernacular house.

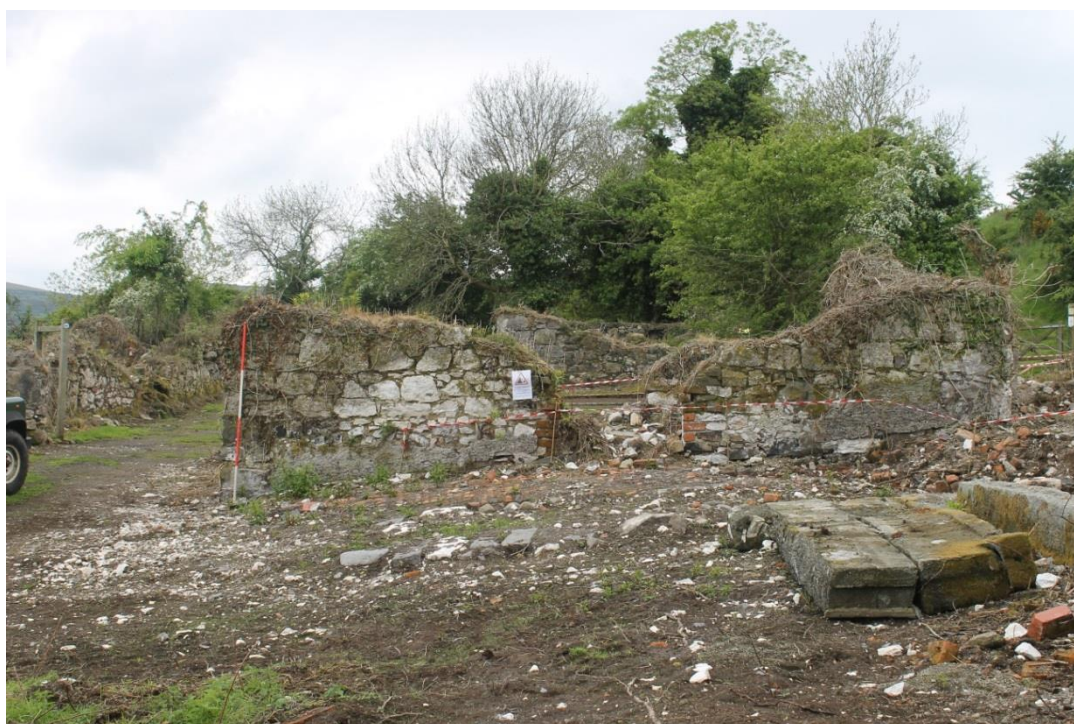
Figure 12: Cow shed, looking south west.

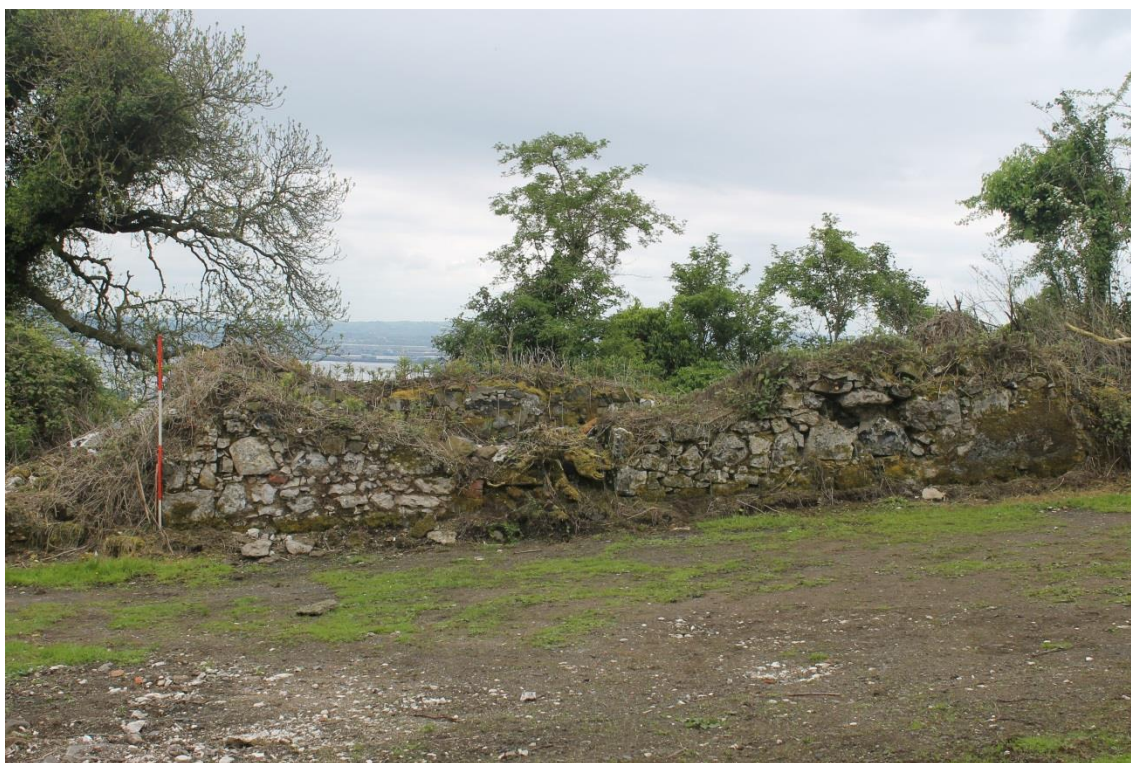
Figure 13: Hay barn, looking south south east.

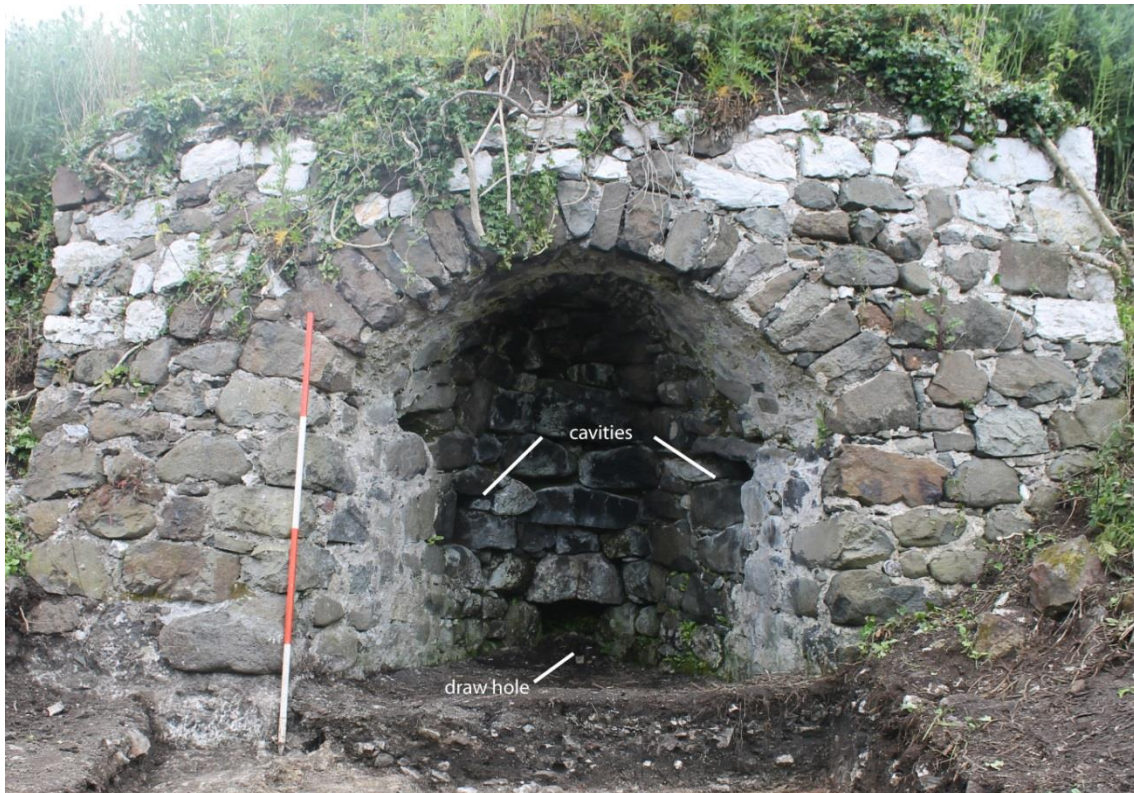
Figure 14: Cavities and draw hole within the arched recess, looking west.

The lime kiln, in comparison to the farmhouse, has survived remarkably well. Dunanney Lane curves around the lime kiln and the steep rise would have allowed for access to the furnace shaft from above. It stands 3.16m in height and is 5.4m across. As with the farmhouse, the kiln is built from lime and basalt blocks bonded with lime mortar. The draw hole is entranced by an arched recess (Figure 5), which currently measures 2.36m wide and 2.4m deep. The recess appears to be constructed using an arch at the mouth which extends into the recess 1.2m. The roofing at the rear of the recess is corbelled. There are three cavities within the arched recess. One, the draw hole, is located centrally at the back, and measures 0.37m wide and 0.56m deep (Figure 14). The top is 0.33m from the present ground surface. This is where the lime was removed from once fired. Two cavities are located in the walls of the recess (see Figure 14). One to the right of the entrance, in the northern wall, 1.16m from the entrance, is 0.8m from the present ground surface and measures 0.4m wide, 0.35m in height and is 0.56m deep (Figure 15). The other to the left of the entrance, in the southern wall, is 1.7m from the entrance and is 0.6m from the present ground surface. It measures 0.23m wide and 0.29m in height and is 0.46m deep (Figure 16). The function of these side cavities remains unclear, however, they perhaps held a lamp for workers tending the kiln by night or were possibly even used as ovens to warm food for the workers. A possible vent or stoke hole is located just above the centrally located opening at the back of the recess. This appears as an unmortared gap between two basalt blocks.

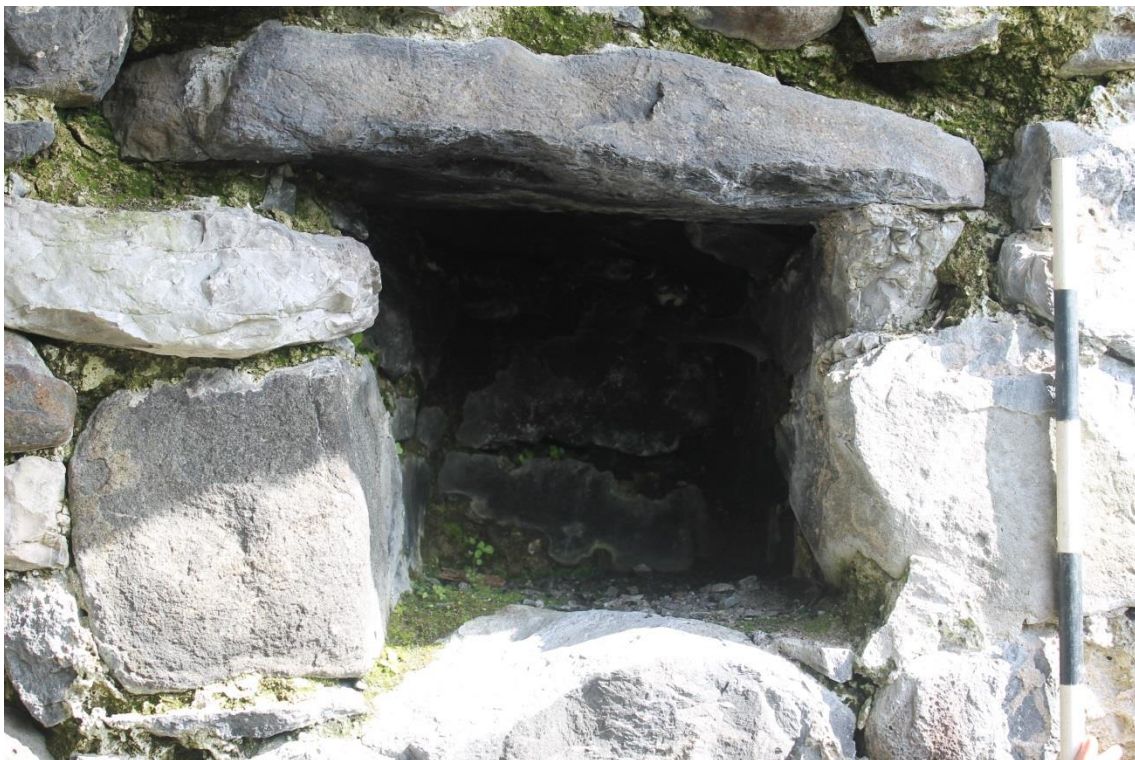
Figure 15: Cavity in the northern wall of the recess, looking north.

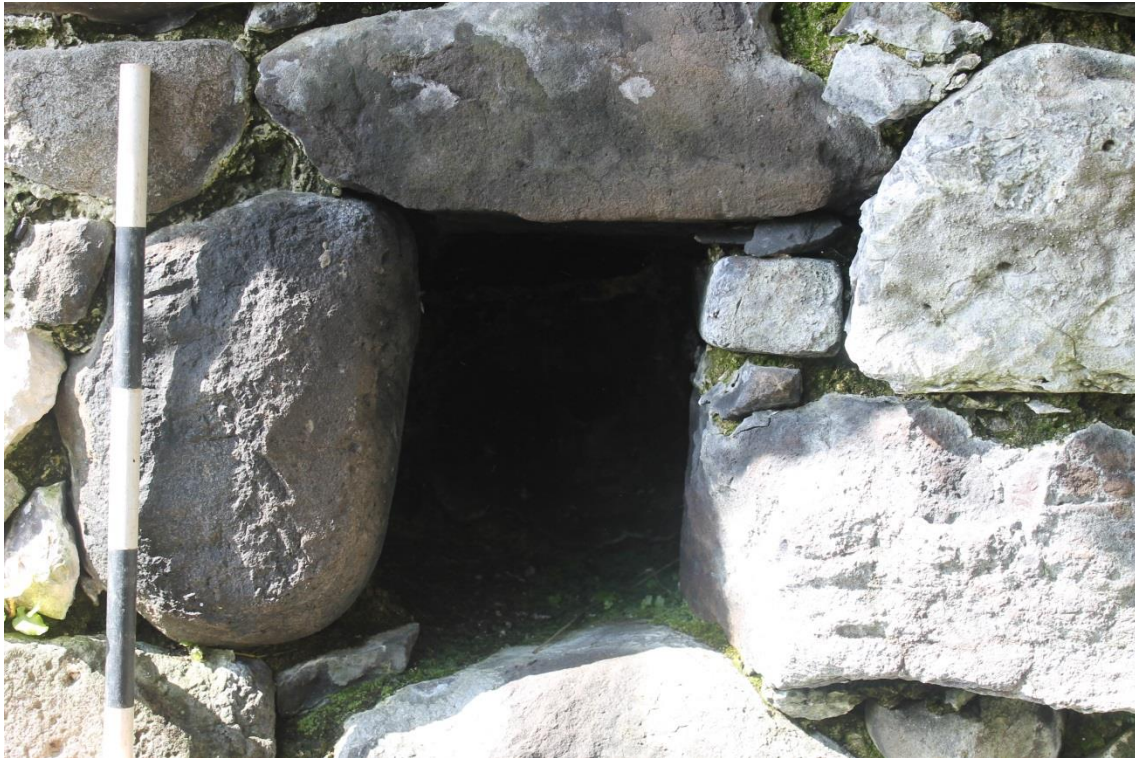
Figure 16: Cavity in the southern wall of the recess, looking south.

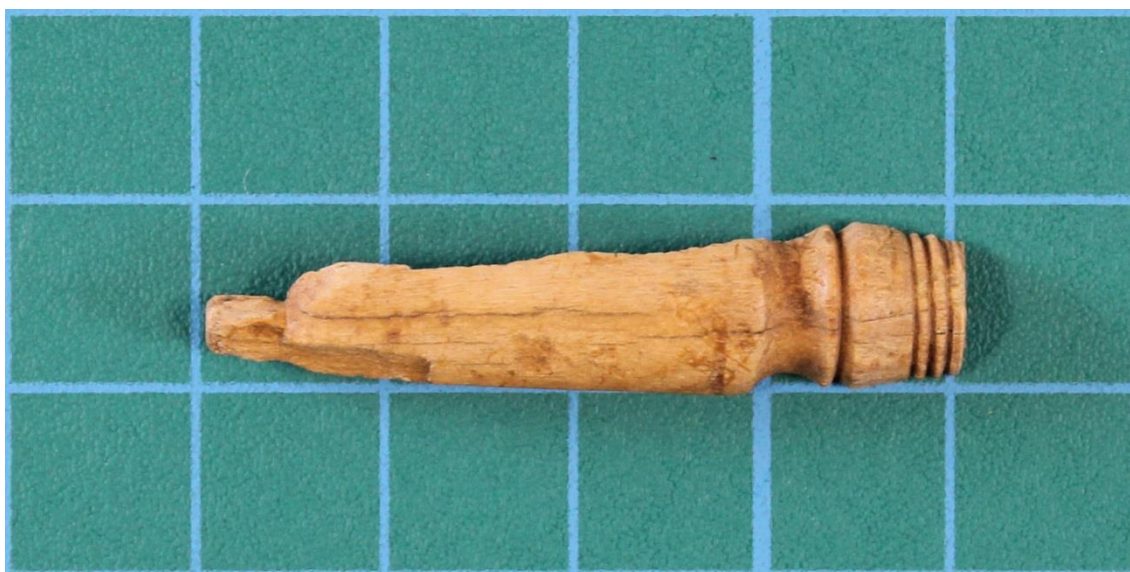
Figure 21: Decorated bone artefact, possibly a handle or toggle, recovered from c302.

coins dated to 1938 and 1944, some clay pipe stem fragments and a decorated bone piece, possibly a handle (Figure 21). On removal of the clay loam (c302) a layer with a high lime content (c303) was uncovered. This layer (c303) was higher at the south and stepped down towards the north, with an east west running slope (Figure 22). The lime layer was thinly spread (0.02-0.06m) over the red-brown clay subsoil at the north and was thicker (up to 0.15m) at the south where it overlay a hard packed mortar layer (c306; Figure 23).

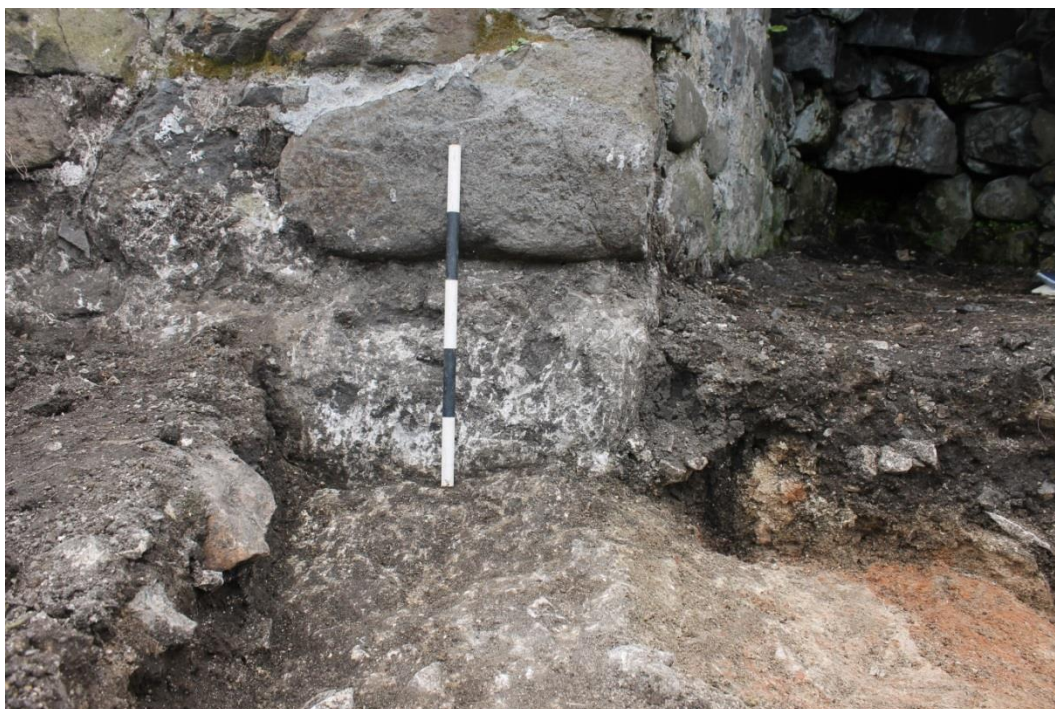
Figure 26: Lime kiln wall, set on foundation of hard-packed mortar (c306).
